Hotspot analysis – Murang'a county

Technical report

December 2025

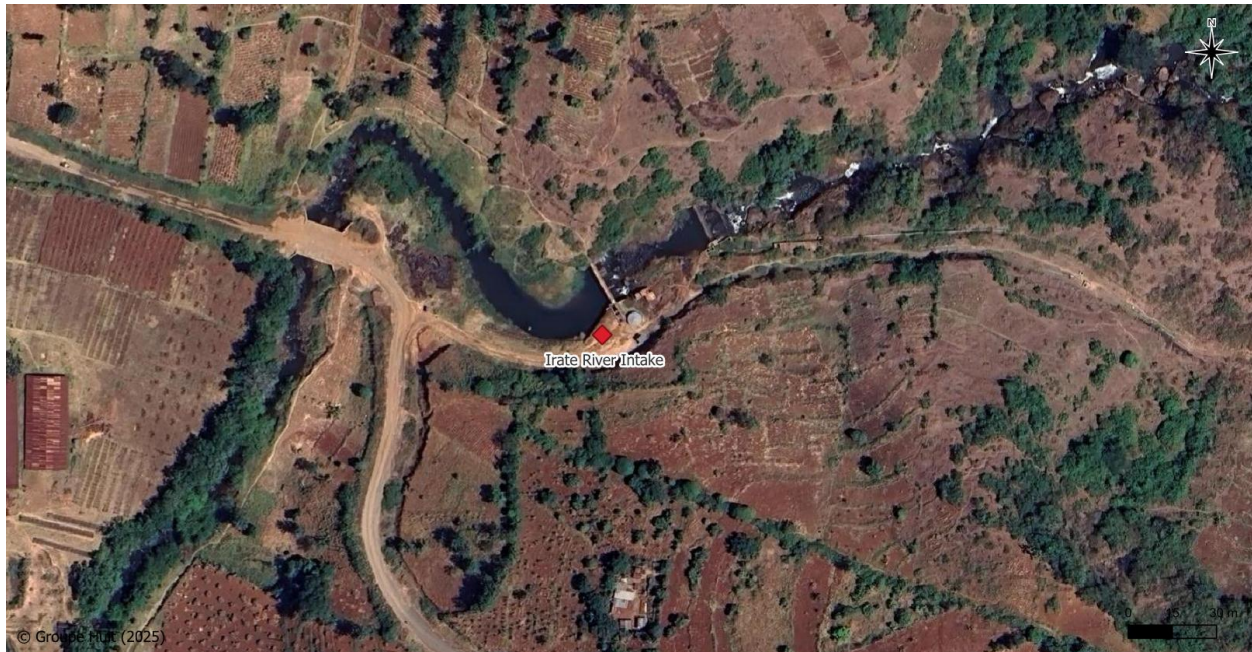
Figure 9: Location of Irate water intake

Coordinates : -0,78481096 ; 37,0116800

The Irate Intake is situated on the Irate River in Gachocho area of Kigumo Sub-county, an area characterized by hilly and steep slopes. The slopes are dominated by nutrient-rich, loamy red volcanic soils, which make the land highly suitable for cultivation. As a result, much of the area is under farming, while in some sections, rock outcrops with limited vegetation cover are visible. This lack of firm ground cover makes the slopes highly susceptible to landslides and rock falls. These hazards are most common during the rainy season, particularly in May, when the soils become saturated and unstable.

It is proposed to lay a parallel line from the intake to the treatment plant and rehabilitating the existing channel.

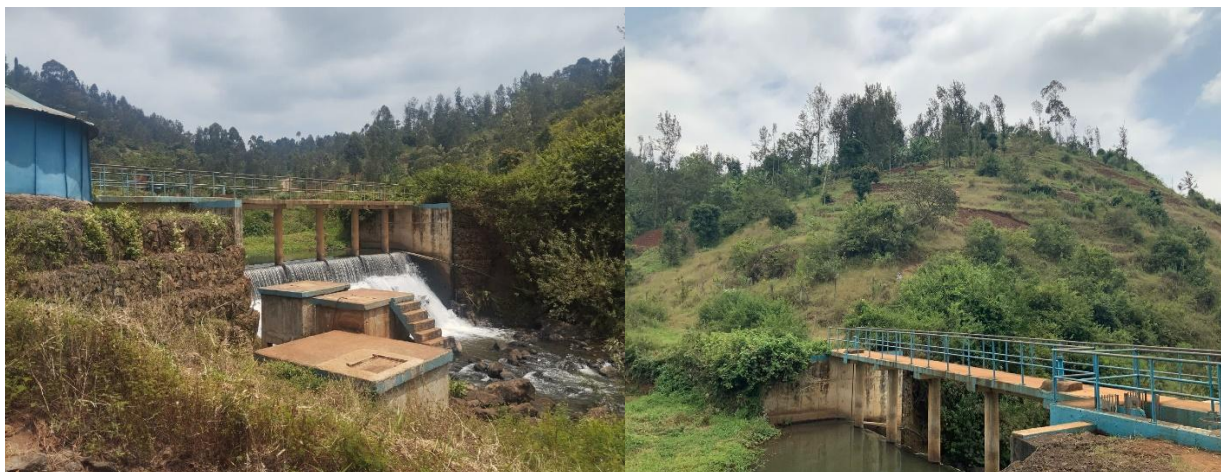
Figure 10: Irate Intake on River Irate in Gachocho area.

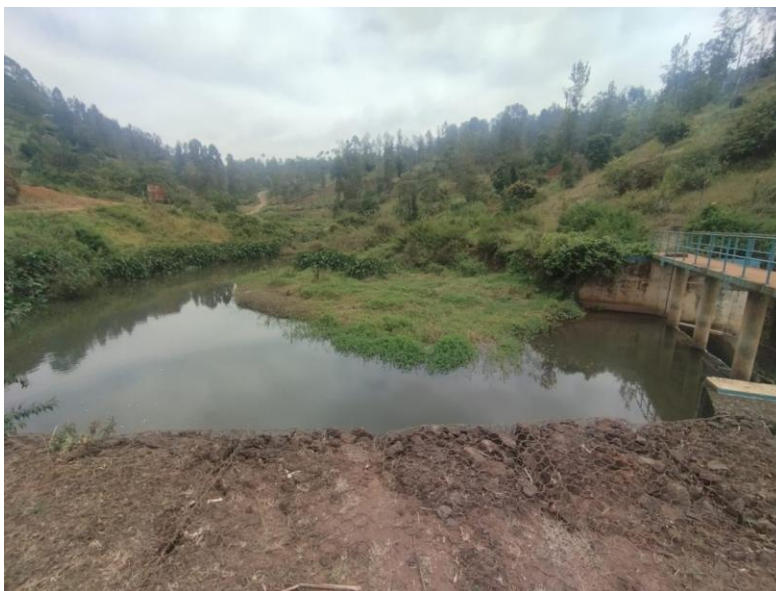
Figure 11: Shrinking Irate Intake reservoir capacity as a result of siltation caused by soil erosion

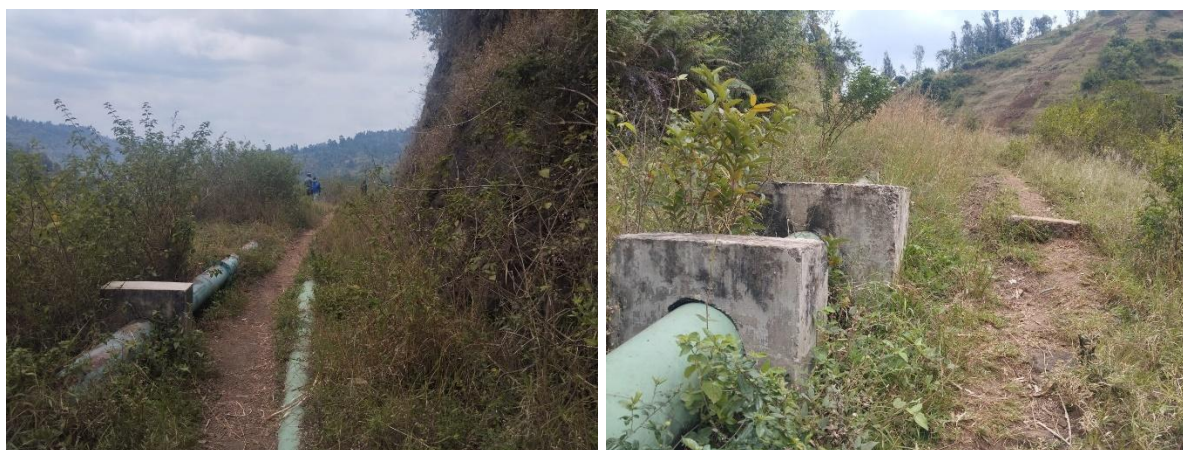
To reduce the risks posed by landslides and rock falls, several engineering interventions have been implemented. Pipe anchors have been reinforced with concrete up to 7 meters into the hardpan, providing greater stability in vulnerable sections. In areas with high rock fall risk, the pipeline has been diverted away from rocky zones or buried deeper underground to minimize exposure and damage.

Figure 12: Water Supply HDPE pipes anchored by reinforced concrete anchors along the foot of the slopes to deter impacts of landslides and rock fall at Irate Intake. Second phot also show evidence of poor slope clearance and cultivation

Use of HDPE pipes that are much stronger and can withstand damage. Reducing the number of joints within the hotspot zone by electro fusing the joints.

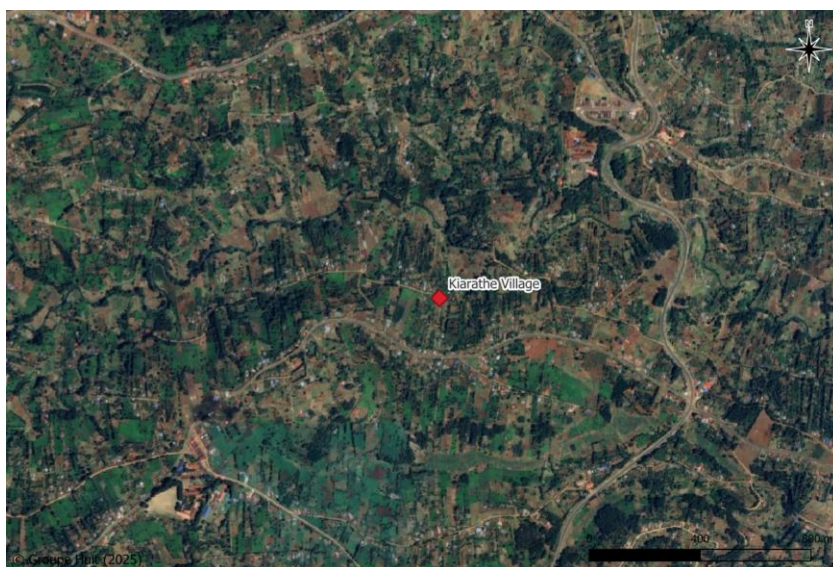
Coordinates : -0,6683542 ; 36,9519700

The exact areas for pipe rehabilitation is unknown, the map above presents the overall area, showing that houses are scattered along roads and that the area has steep slopes.

Located in Musoso Village, the area has steep slopes with loose red volcanic loamy soils. The vegetation cover along the slopes is scattered mostly made of tealeaves, coffee trees and other agricultural plants like bananas and in some cases nappier grass. The continued farming along these steep slopes expose the pipes to risks of landslides.

It is proposed to rehabilitate the water supply pipes.

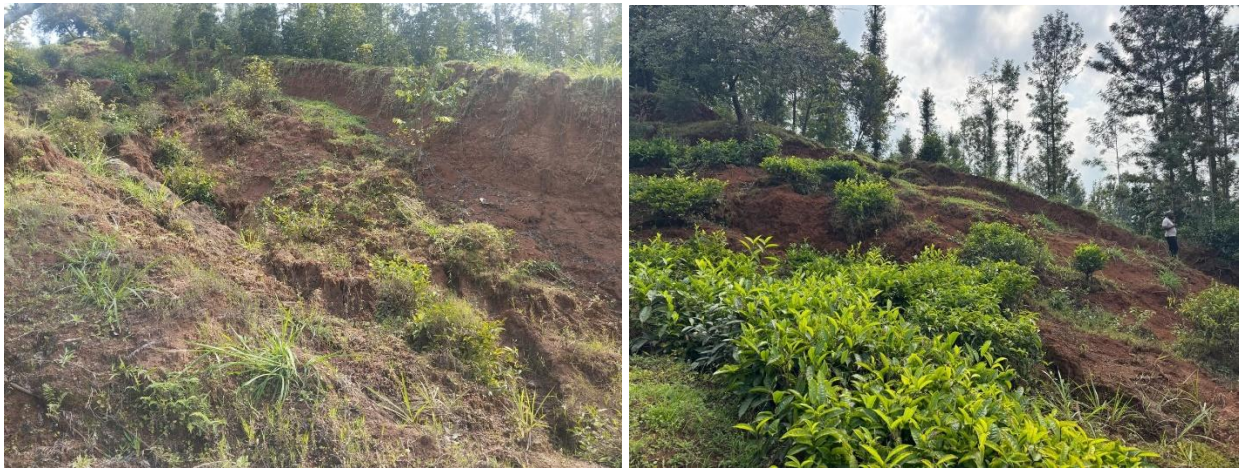
Figure 13: Impacts of Landslides in Kiarathe, Crops swept away as mass movement continues downhill

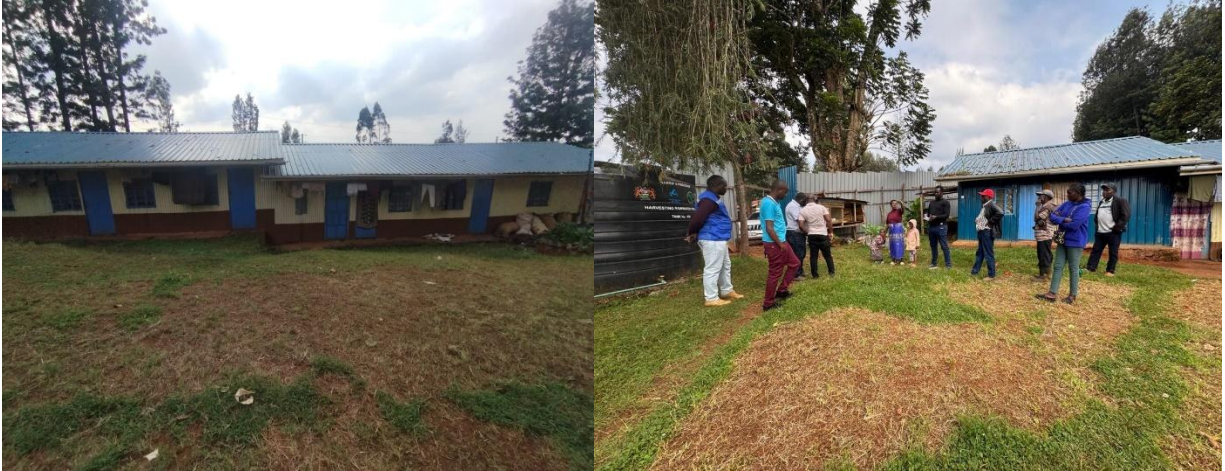
Figure 14: IDP Camp housing at Kiarathe Academy

Twenty-one families were displaced to the IDP camp, have been provided by a shared kitchen, and piped water supply from MWEWASCO. Each family has been provided with a 3-bedroom house and for the single one a two-bedroom house. The church pays for water and electricity bills for the IDPs. There are also adequate sanitation facilities at the camp for the IDPs.

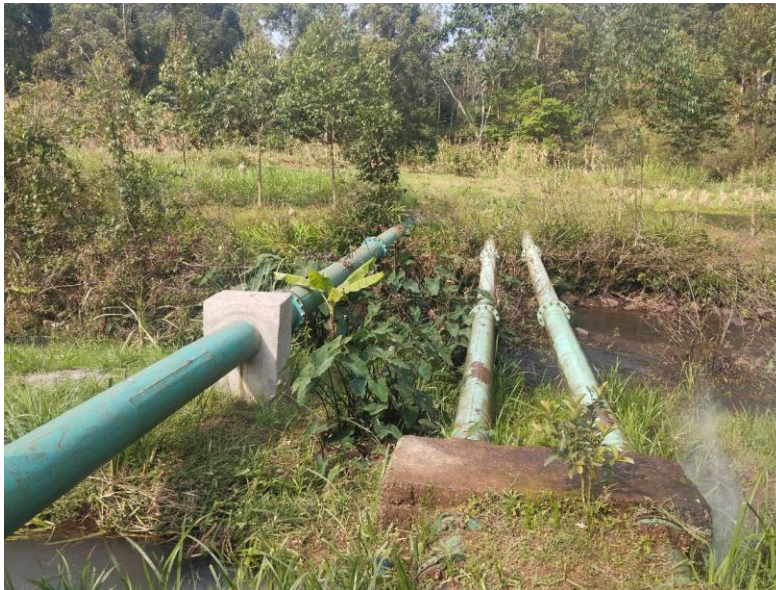
Galvanized Iron (GI) pipes have been installed across structurally weak sections of the supply network, particularly at river crossings. At these points, a concrete reinforced joint chamber with a washout has been established to secure the crossing and enhance maintenance.

Figure 15: Relocated pipes running along River South Mathioya valley in Kiarathe with river crossing fitted with GI pipes from the joint chambers and firmly anchored by concrete reinforced anchors.

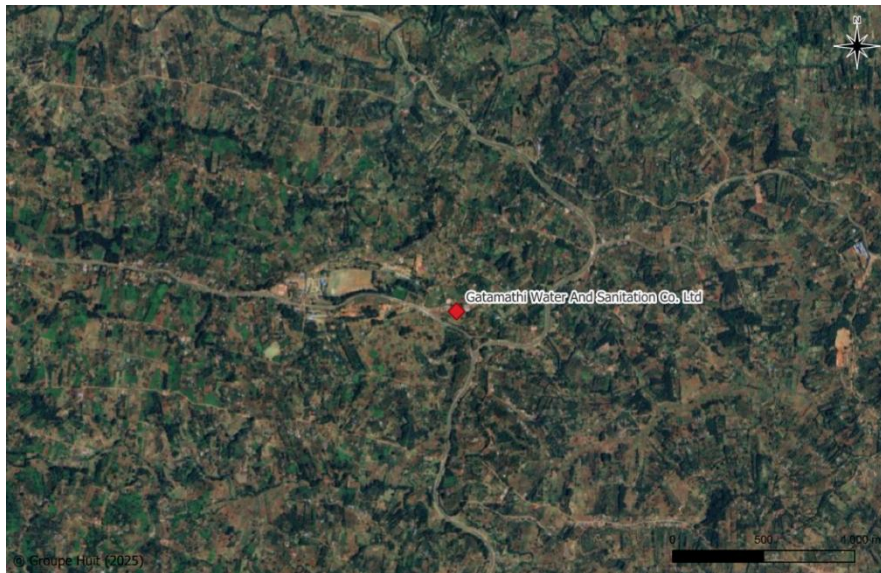
Coordinates : -0,64229494 ; 36,9578800

The exact location and extent of the proposed project remain to be mapped, the above maps mainly intend to show the hilly terrain of Gatamathi.

The Gatamathi Water and Sanitation Company (GAWASCO), which manages the Gatongo and Mathioya Water Schemes, has planned a water supply extension and metering programme targeting residents of Kiambuigi, Mugeka, Gatari, Kigetuiine, Thoithu, and Karengo-Ruiru. These areas are recognized as landslide hotspots, characterized by steep slopes, loose loamy red volcanic soils, and unsustainable farming practices along the hillsides. Landslides in the region are most frequent in May, coinciding with the heavy rains when soils are fully saturated.

Extension of water supply network and metering to Kiambuigi, Mugeka, Gaturi, Kigetuiine, Thoithu and Karengo-ruru.

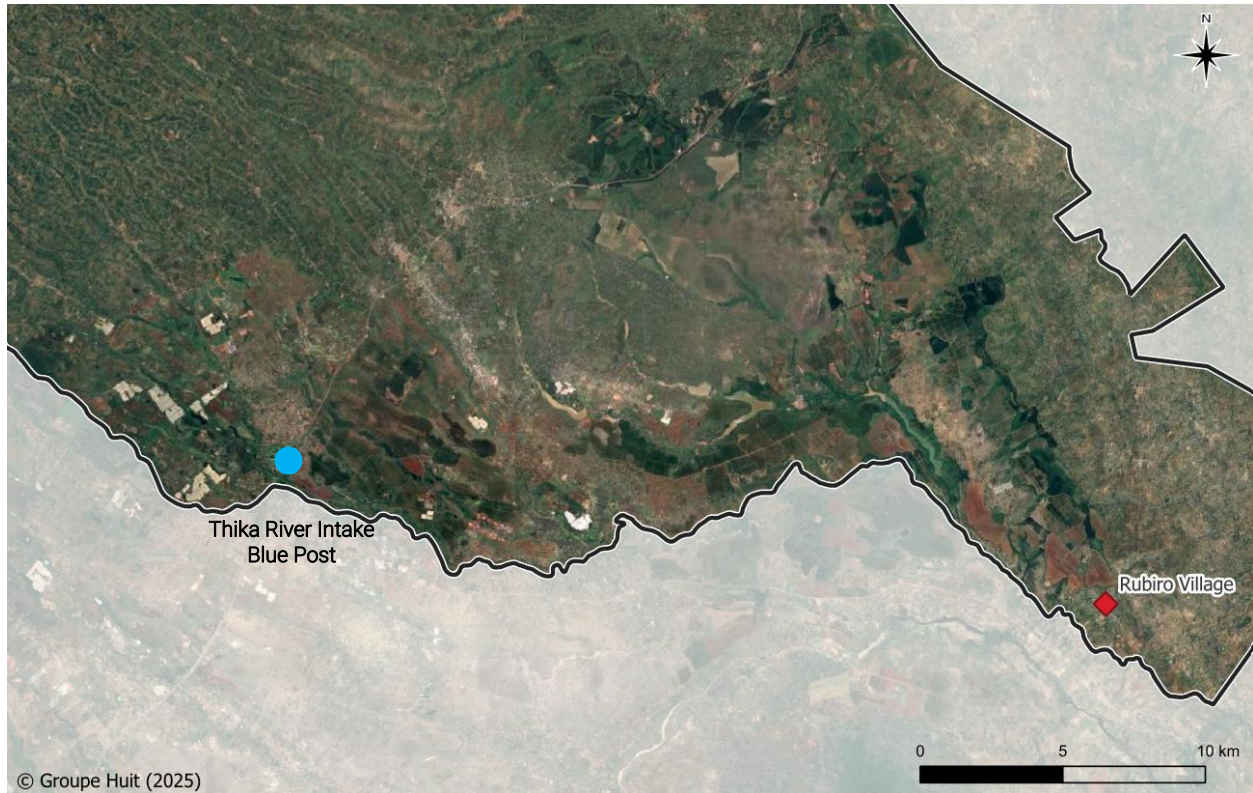
Coordinates : -1,062716200 ; 37,3290520

The Gatanga Water and Sanitation Company has planned a water supply extension to the areas of Mavoloni, Muti, Ngereria an Mkundi, Kakiuzi and Mito Mbili in Ithanga Sub-County, a region severely affected by drought with occasional flash floods. The area is characterized by high temperatures and erratic rainfall, with rains mainly occurring between March and May.

Extension of Water Supply in Mavoloni, Muti, Ngereria an Mkundi, Ithanga, Kakiuzi and Mito Mbili areas in Ithanga sub-county

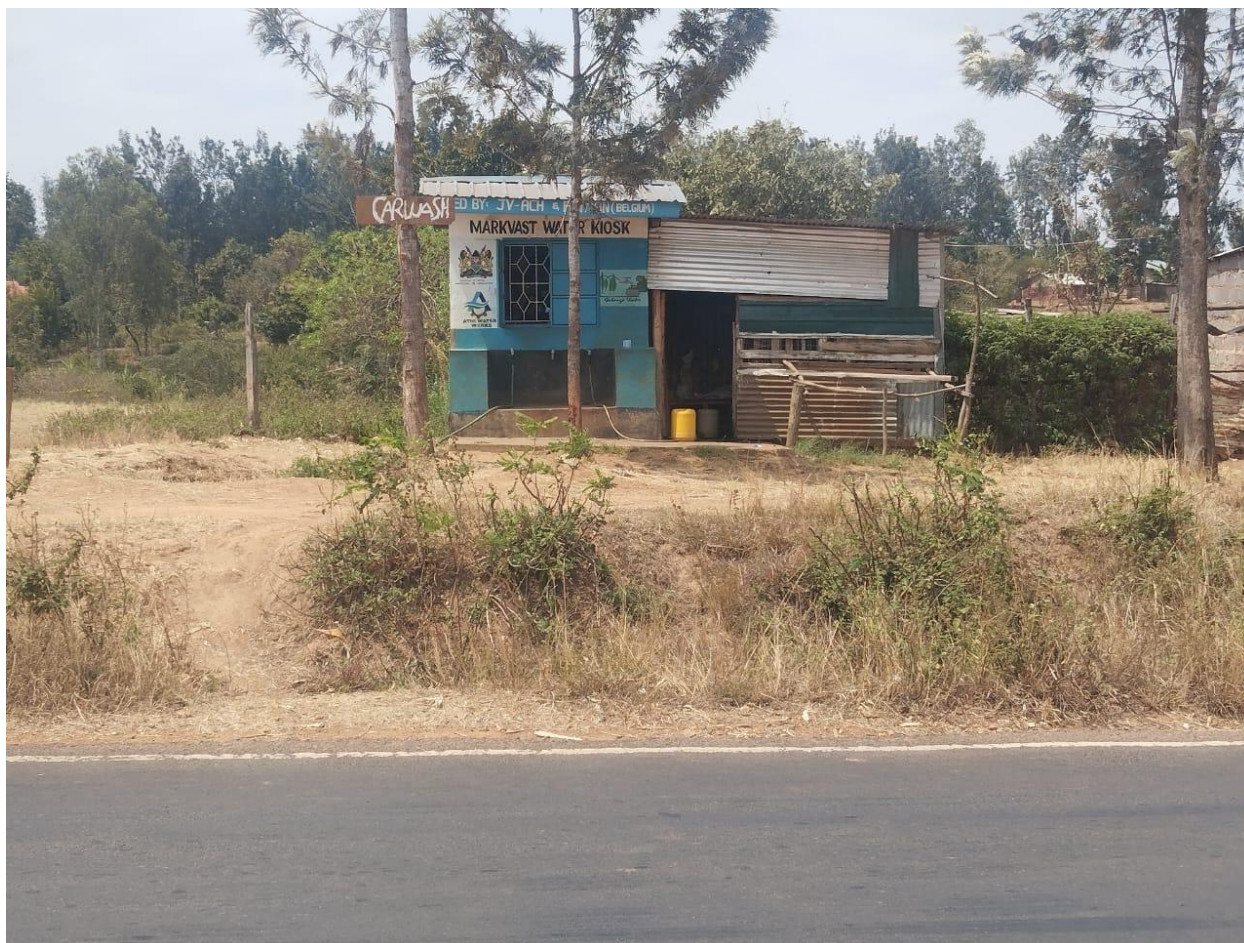
Figure 16: One of the water kiosks in Rubiro Area, Ithanga.

The planned expansion will draw water from the Blue Post intake on the Thika River, conveyed through a 400 mm main pipeline. Currently, the company manages about 1,800 active connections (roughly 30% coverage), supported by water kiosks and water pans. Demand for household connections remains high, particularly as this part of Murang'a borders Machakos County, where Gatanga Water is permitted to supply up to 1 km across the county boundary.

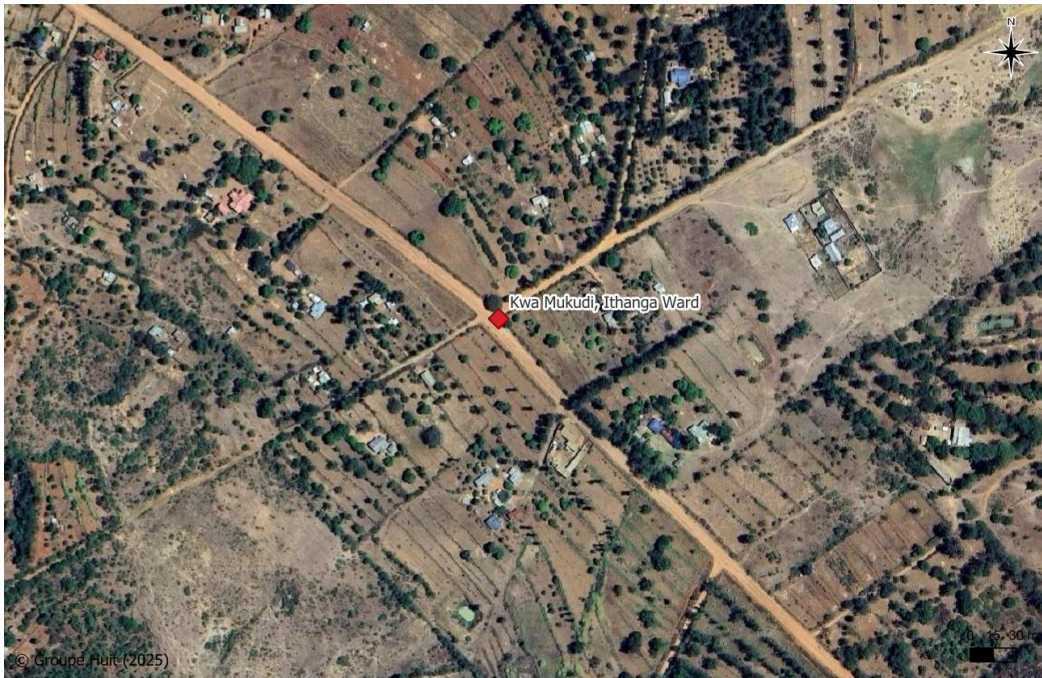
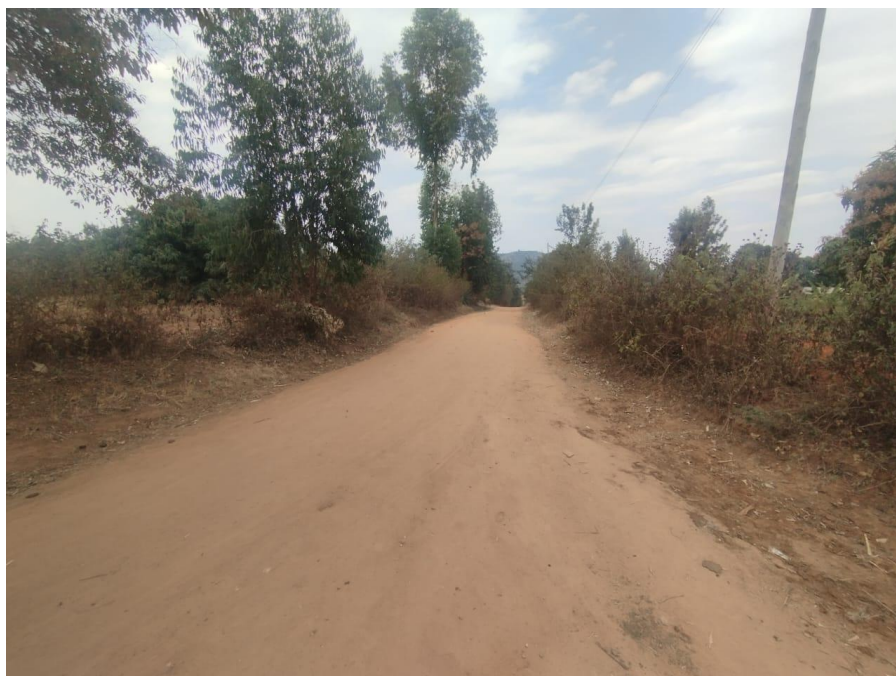
Figure 17: Road to Kwa Mukudi village where the main trunk line of the current water supply is located.

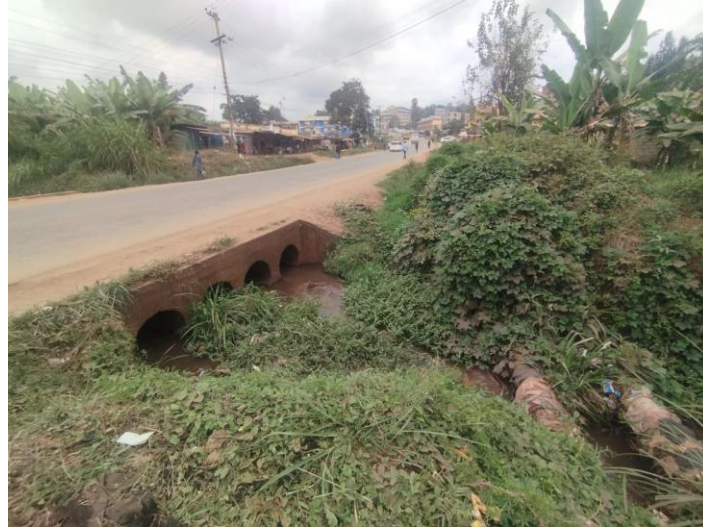
The sewer pipe rehabilitation site is located in the Kimamo area along River Gathamba, near the MUWASCO offices in Murang'a town. The pipes are heavily affected by flooding, which damages the infrastructure and causes sewage to leak into the river, leading to water pollution. Similar challenges are also observed in the Kwa Base area within Murang'a town. Flooding occurs annually between February and April and is mainly caused by the river when it bursts the banks

Figure 18: Sewer pipes crossing River Gathamba near Muwasco Offices.

Heavy flooding frequently damages sewer pipes, causing sewage leaks into River Gathamba. This leads to water pollution and heightens health risks, with cholera outbreaks being common in the area.

The County is in the process of replacing the damaged sewer pipes with Galvanized Iron (G.I.) pipes. These pipes are stronger, more resistant to corrosion, and offer greater durability compared to the previous materials, thereby reducing the risk of frequent breakages and leakages.

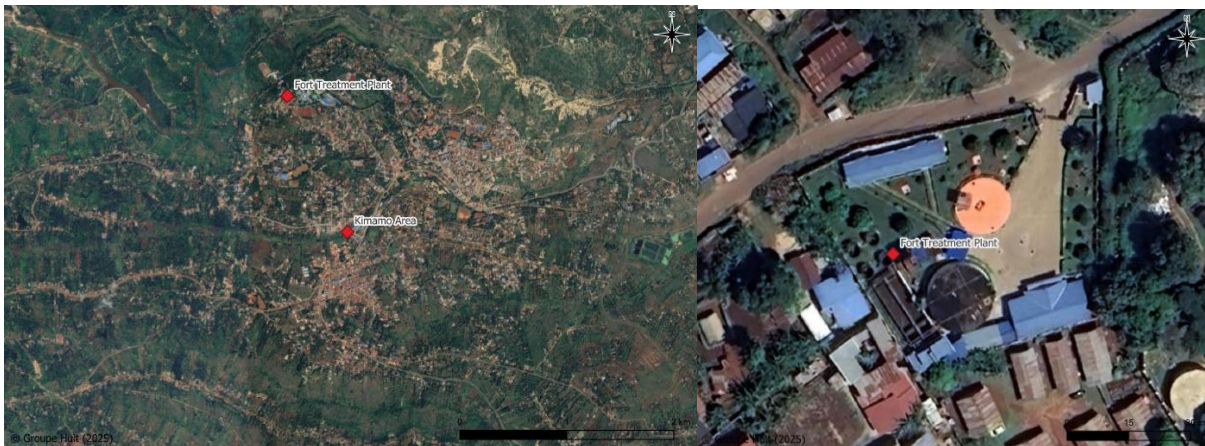
Coordinates : -0,71592593 ; 37,1457750

The treatment plant is located in Kiawambeu area. It draws raw water from the Irate intake on River Irate, situated about 17 km away, through G.I.-coated pipes. While landslides or erosion does not directly affect the plant itself, its operations are indirectly impacted by changes in water quality originating at the intake. The design capacity of the facility is 10,000 cubic meters but currently serving 9,800 cubic meters only. The facility as designed and constructed by the Tan/Athi Water Development Authority and handed over to MUWASCO for operations.

- Rehabilitation of the Irate Raw Water Main Intake on Irate River
- Construction of a sedimentation Basin
- Construction of another intake on Irate River to supply raw water to Fort Treatment Plant
- Rehabilitation of Fort Treatment Plant

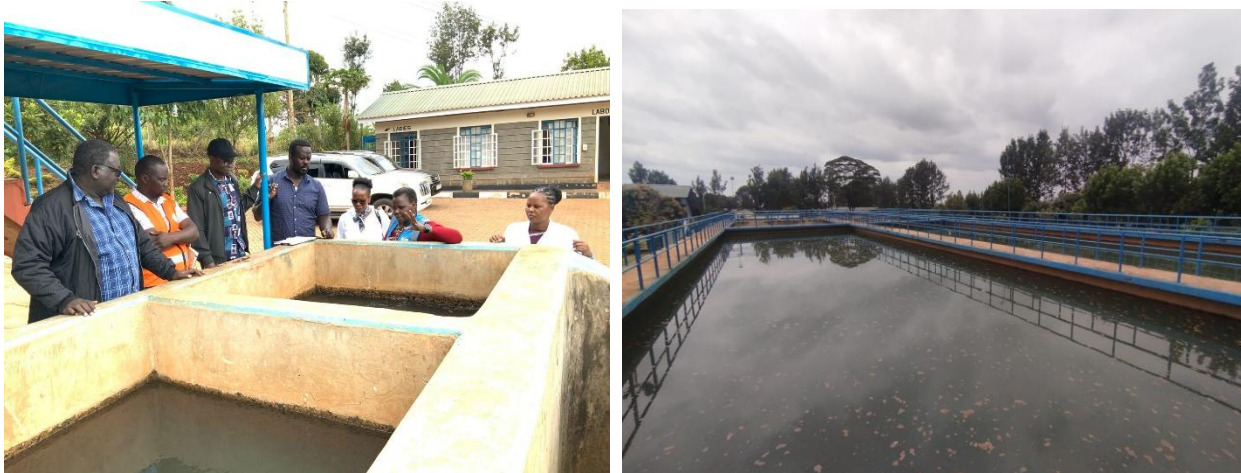
Figure 19: Sedimentation and Dosing Chambers at the treatment plant

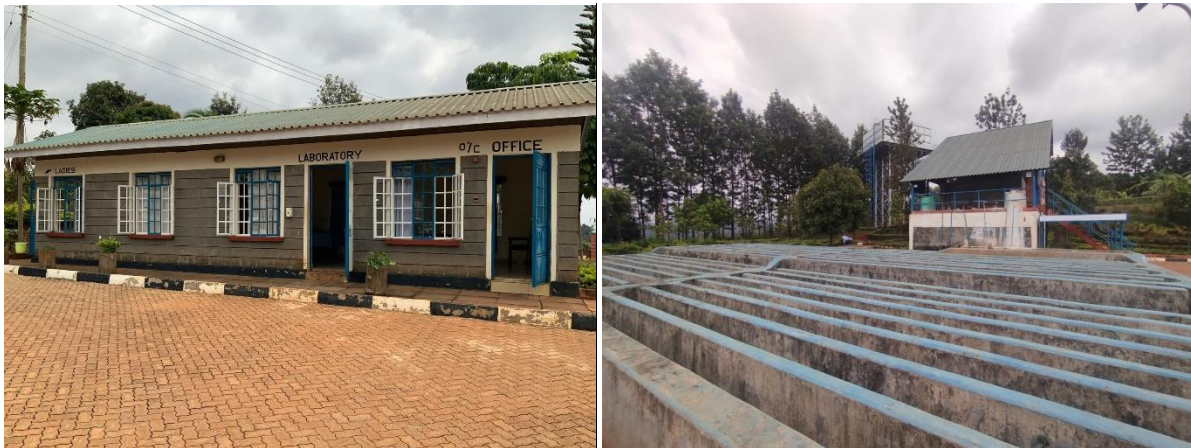
Figure 20: Testing Laboratory and Sedimentation Chambers at the treatment plant

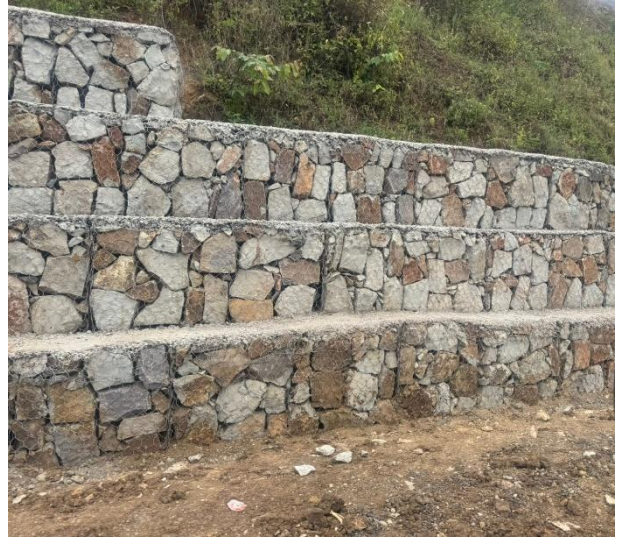
Reinforced concrete pipe anchors are installed to protect pipelines from being swept away or damaged during landslides. Gabions are constructed along slopes to enhance stability and reduce the risk of landslides, as shown in the picture below

Figure 21: Slope Stabilization Gabions along a slope in Murang'a

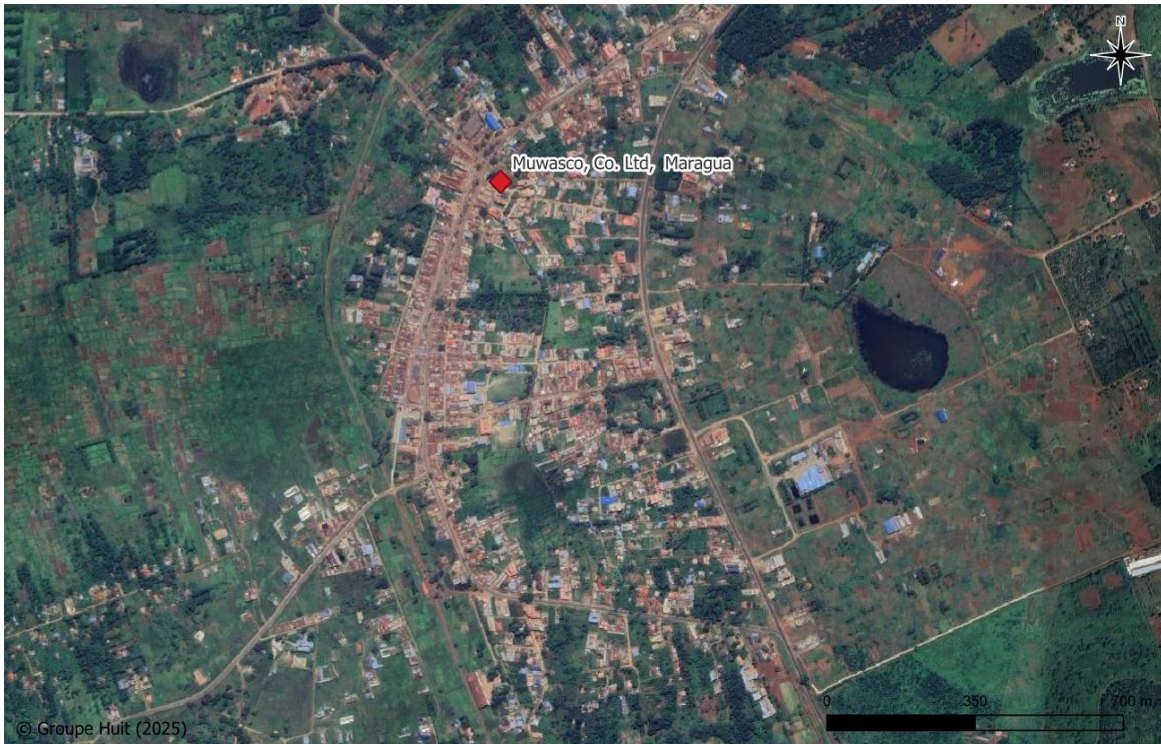
Coordinates : -0,7916032 ; 37,1314200

Maragua town is a rapidly growing municipality, with low-income residents forming the majority of its population. At present, most households rely on pit latrines and septic tanks for sanitation. To improve

Decentralized Treatment Facility and Co-polymer Septic with Bio digesters and sewer network.

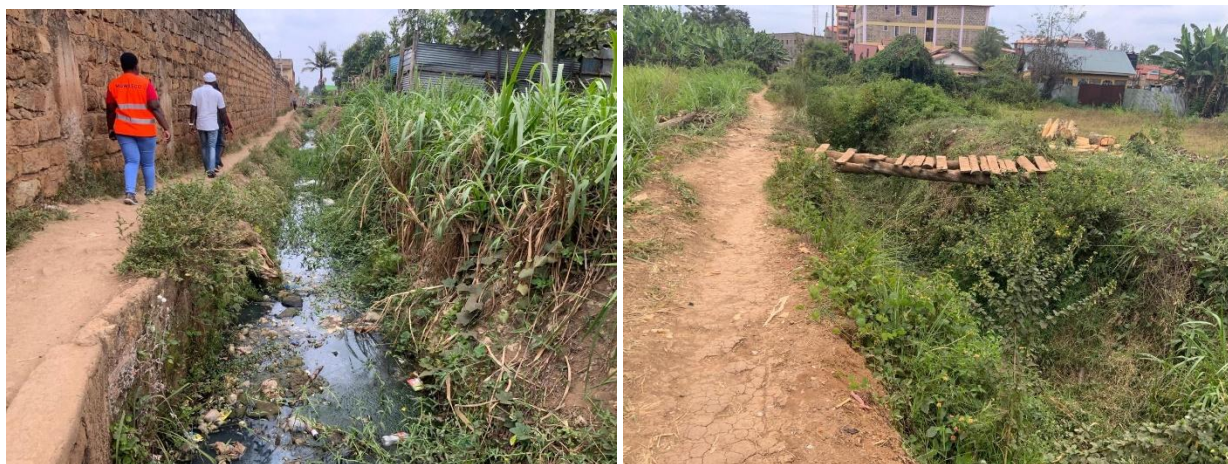
In addition, a large number of households discharge effluents through open sewer systems that flow into nearby trenches, further compromising sanitation and public health as shown below.

Figure 22: Open Sewer Channels in Maragua Town
