# Hotspot analysis– Tana River county

Technical report

December 2025

GLOBAL  
CENTER ON  
ADAPTATION

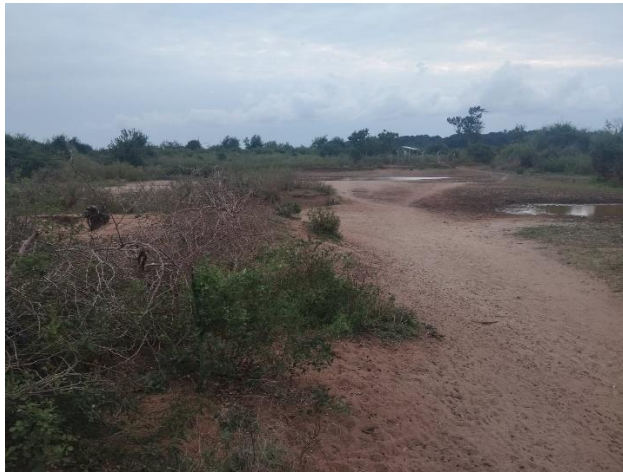
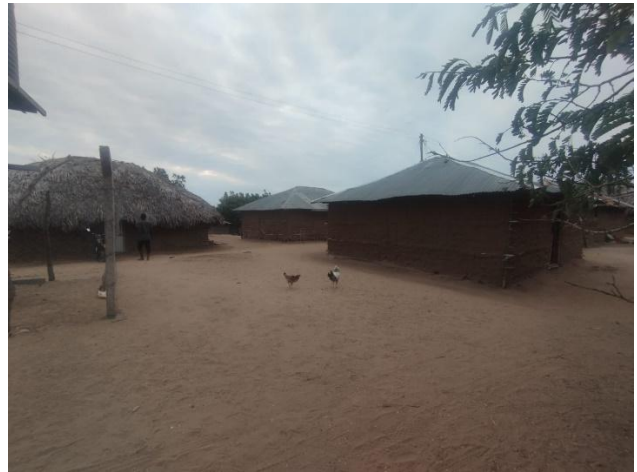
Figure 6: Mkomani Well Field and Community Structures

Situated in Mazuri, the Mkomani Well Field lies within a flood-prone area along the River Tana (coordinates: -1.664° S, 40.139° E). The area has clay soil with poor drainage, surrounded by thicket vegetation, primarily bushes. Stagnant water pools were observed near the well field, indicating frequent flooding. The terrain is mostly flat, with an elevation of approximately 27.7 meters above sea level. Community structures are predominantly grass-thatched, with some iron-sheet roofs also present. The area experience flooding and drought with flooding as the most severe climate related hazard with up to 1km land surface inundated during floods.

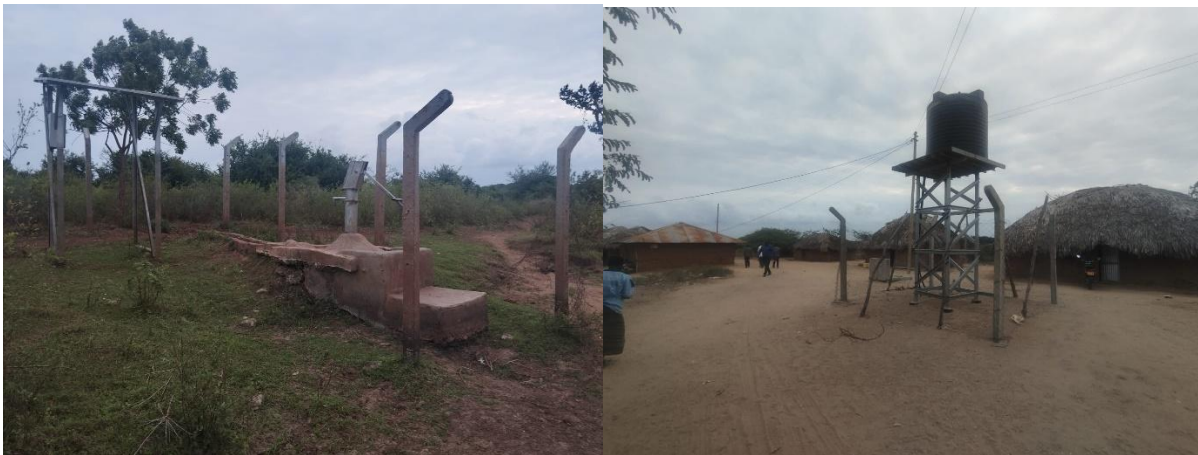
The location has existing water supply interventions, including several boreholes, though none are currently operational. A community borehole developed under the Water Sector Trust Fund (WSTF) programme was equipped by Samaritan's Purse with a solar-powered pump, pipe and an elevated storage tank to supply Mkomani village. Despite the infrastructure remaining structurally intact, the system is non-functional as the hand-dug well exhibited low yield and subsequently dried up after a short operational period.

Figure 7: Mkomani Village Existing Raised Borehole Platform and Community Water Tank

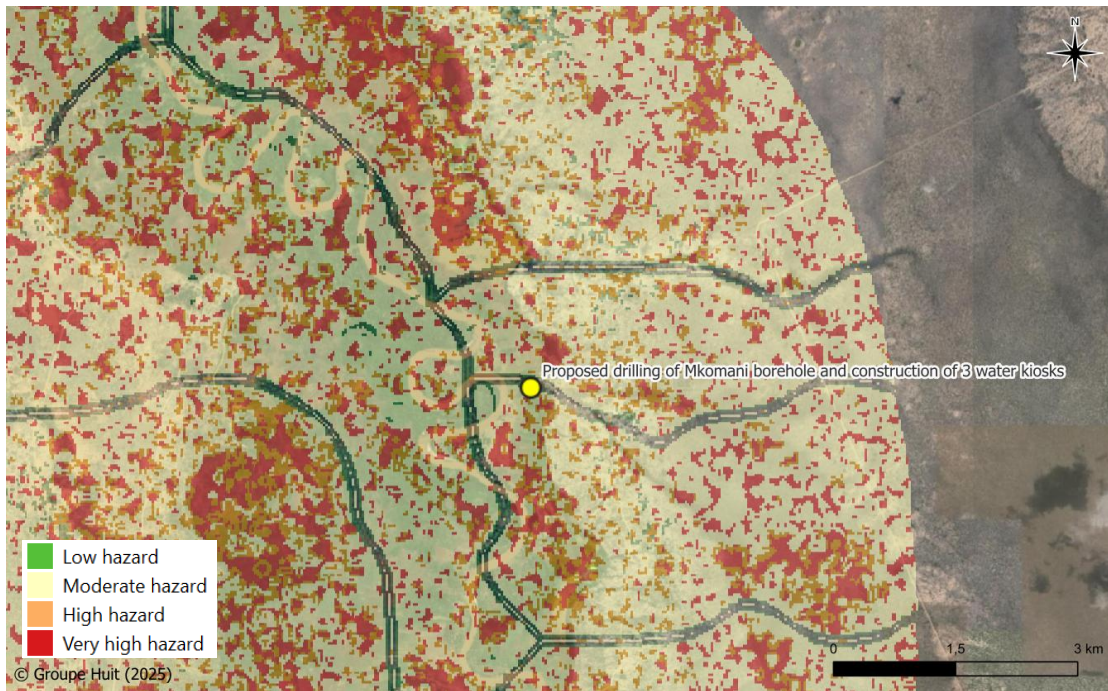
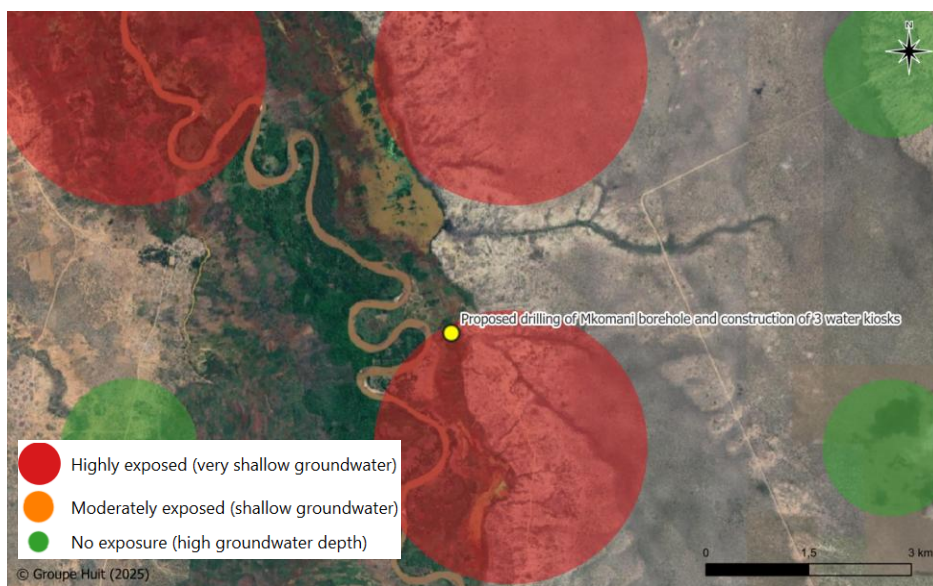
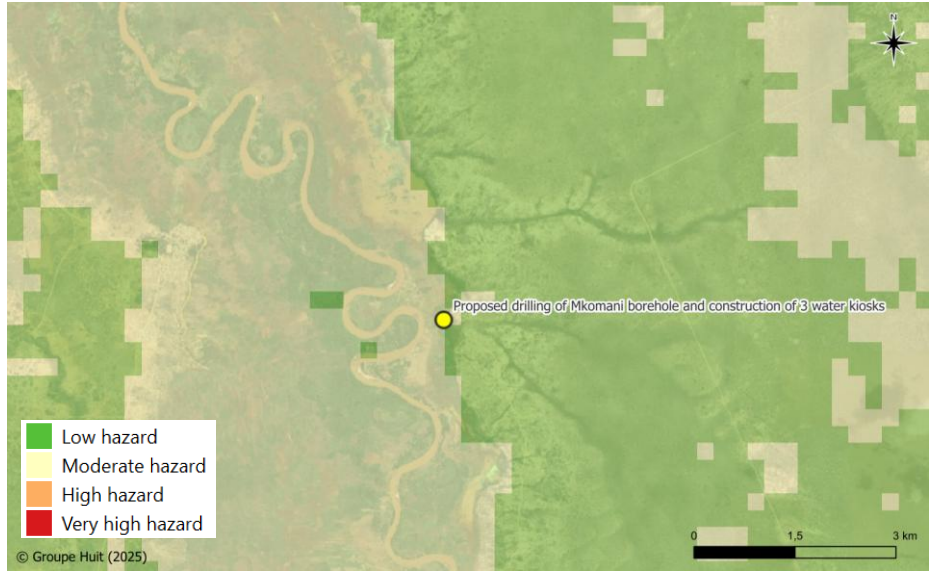
According to GIS analysis of hazards datasets this proposed investment is **very exposed to climate hazards**, especially flooding with **high exposure to both rising water table flooding and river flooding** and to a lower extent pluvial flooding. Salinity does not appear to be the main concern also exposure is considered **moderate**. Finally, Tana River CRA had shown that the area is **highly exposed to heat stress and droughts**, and these hazards should therefore be considered as well.

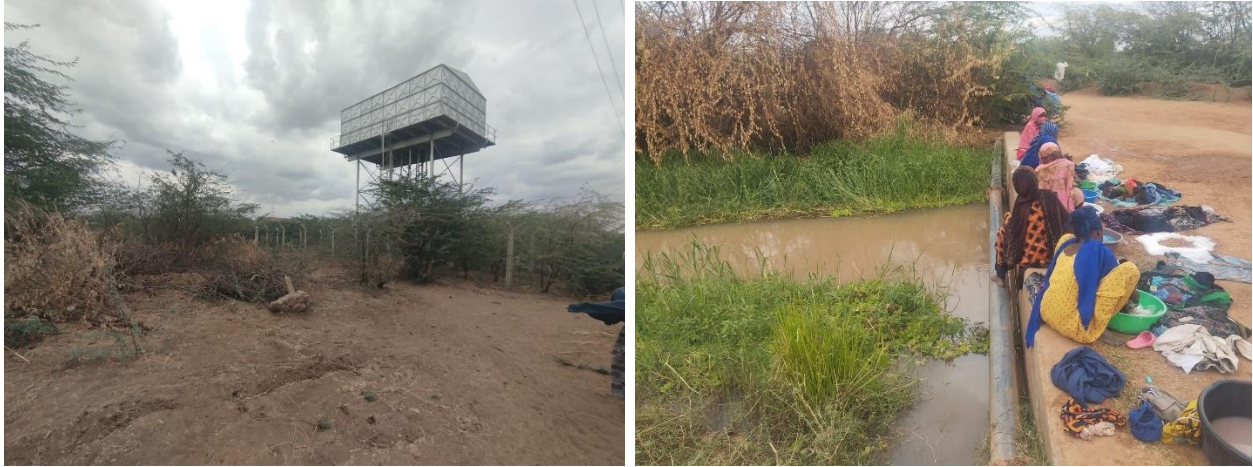
Within the project area, there is an existing pipeline termination connected to two elevated storage tanks constructed and rehabilitated between 1974 and 1979. The tanks, each with an approximate capacity of 250 m<sup>3</sup> and elevated about 9 meters above ground level, remain in good structural condition but are currently not in use. They have been earmarked for integration as storage facilities in the proposed pipeline extension as shown in the image below.

Figure 9: Bura Irrigation Scheme Storage Water Tank and Pipe Termination

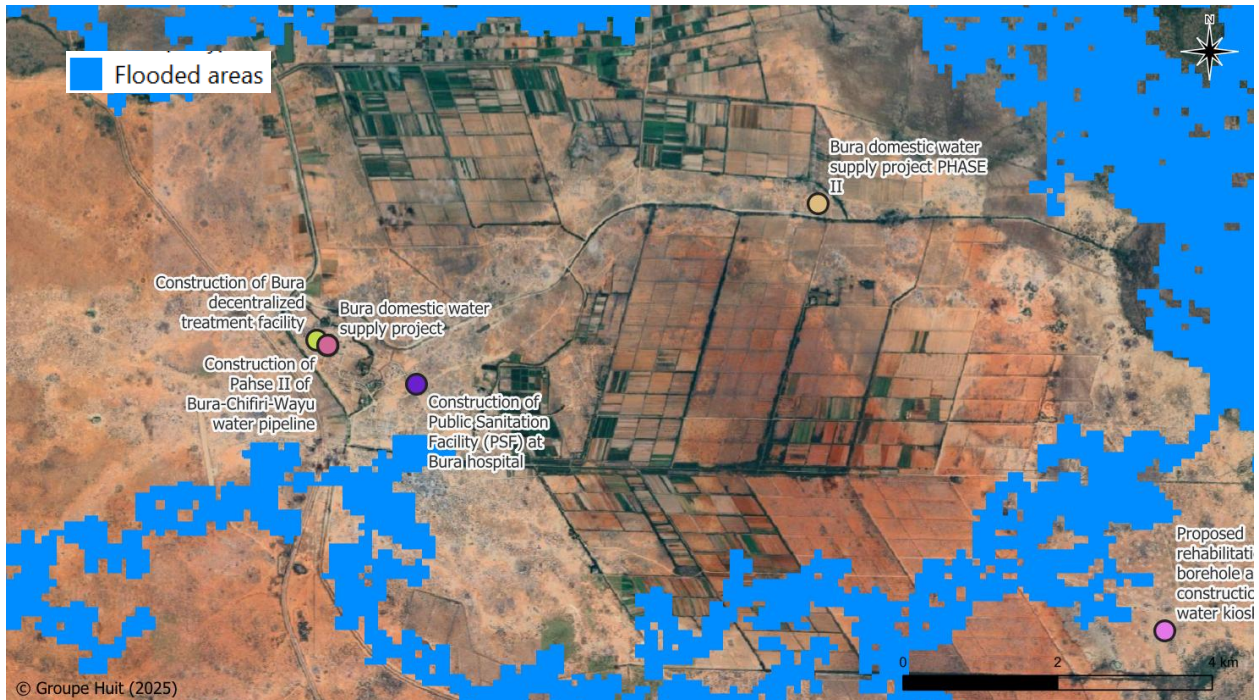
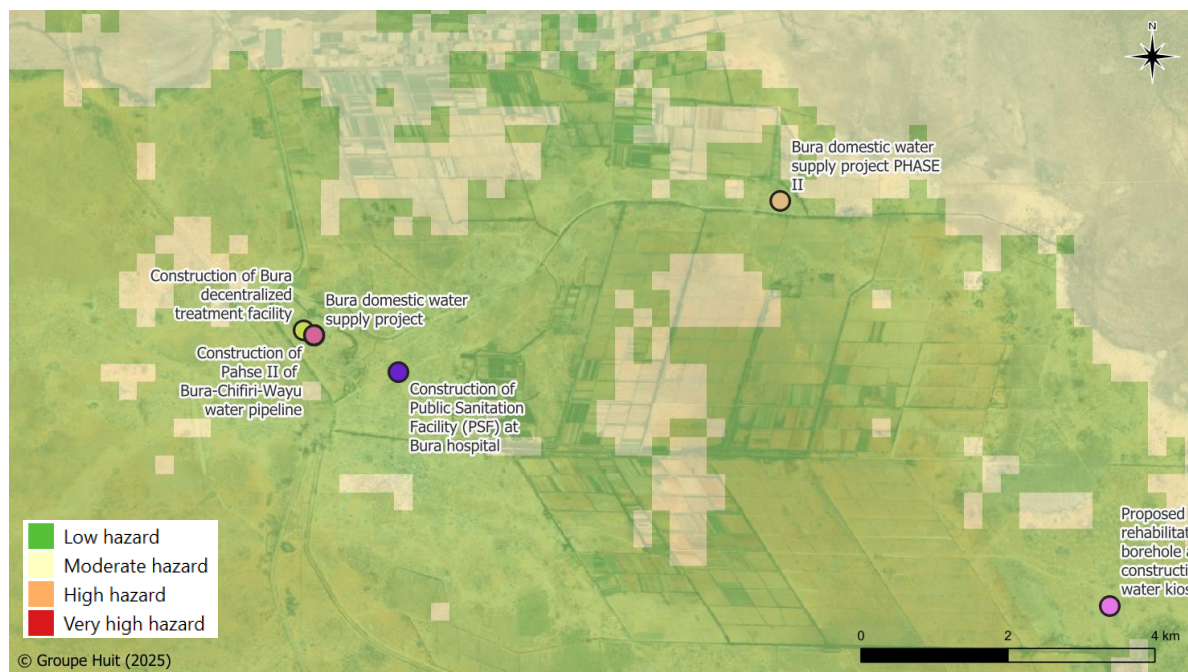
According to GIS analysis of hazards datasets this proposed investment is **moderately exposed to climate hazards**, indeed while the area is **moderately to highly exposed to pluvial flood** it is not directly exposed to rising water tables and river flooding. Salinity exposure is considered low. Finally, Tana River CRA had shown that the area is **highly exposed to heat stress and droughts**, and these hazards should therefore be considered as well.

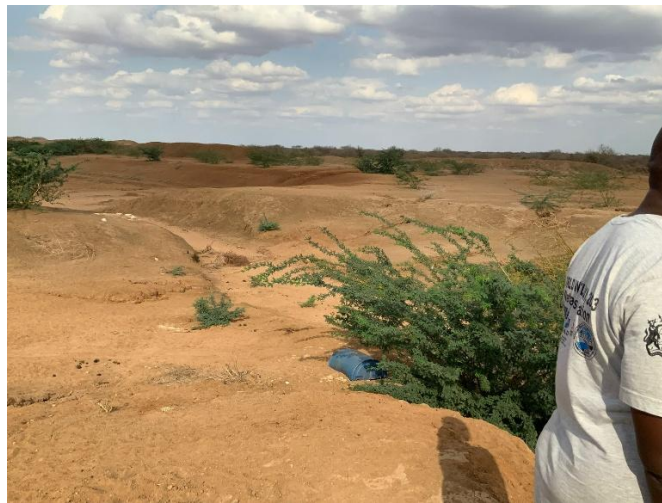
The soils are highly weathered, ranging from fine sandy to clay types, with clay and silt dominating along the laghas, where the proposed water pan is planned for construction. A similar project already exists at coordinate's  $-1.10709^{\circ}$ ,  $39.64743^{\circ}$ , a few kilometers from Wolestokocha Primary School, as shown in the image 8 below. The settlements in this region are sparse but where they exist they are clustered into villages with an average household size of 8 persons per household.

Figure 11: Scenes of the Wolestokocha Lagha channels

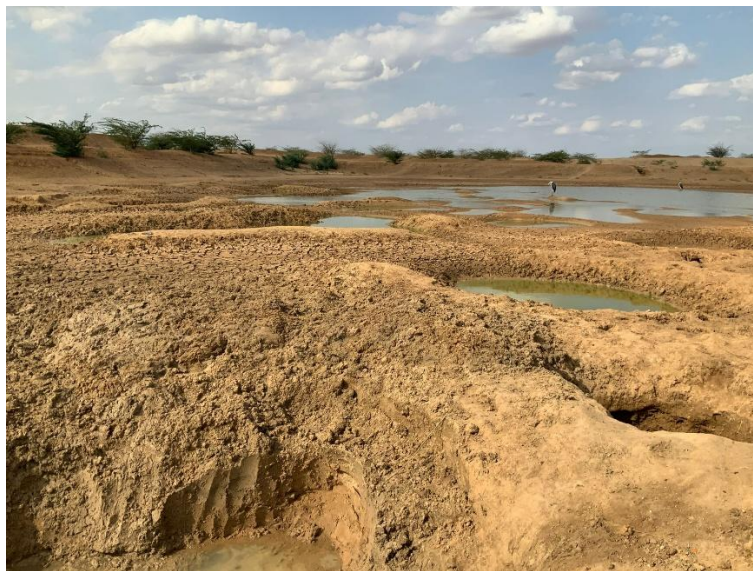
Figure 12: Existing Water Pan in Wolestokocha

The water pan (shown in Figure 15 above) serves as the only alternative water source in the area. However, it dries up during prolonged droughts, compelling the community to dig shallow wells within the pan. These wells are highly prone to contamination from animal waste, and algae blooms frequently develop, rendering the water unsafe for consumption with poor quality and taste. Figure 16 illustrates this contrast, with an algae-infested shallow well on the left and a relatively clean, algae-free well on the right, both located within the same water pan.

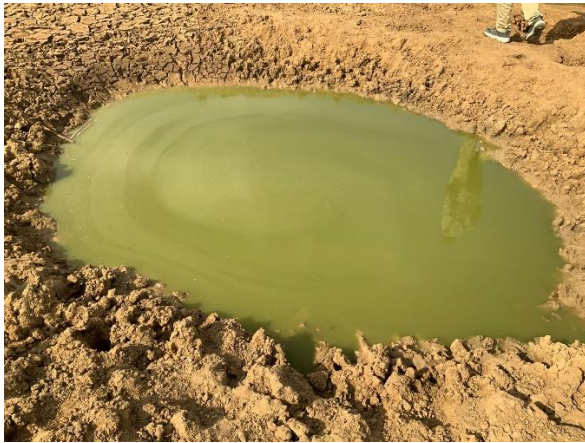
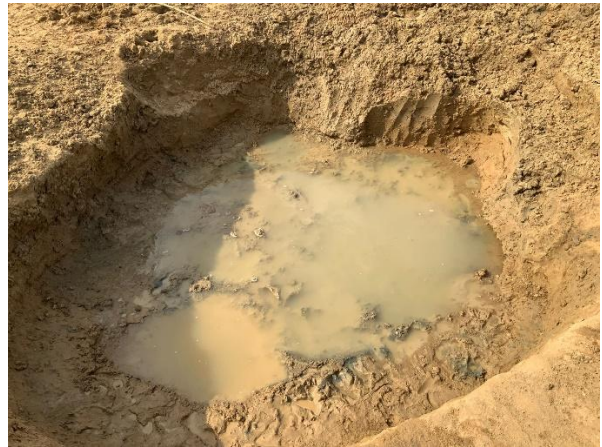
Figure 13: Different water quality Shallow Wells in the same water pan in Wolestokocha

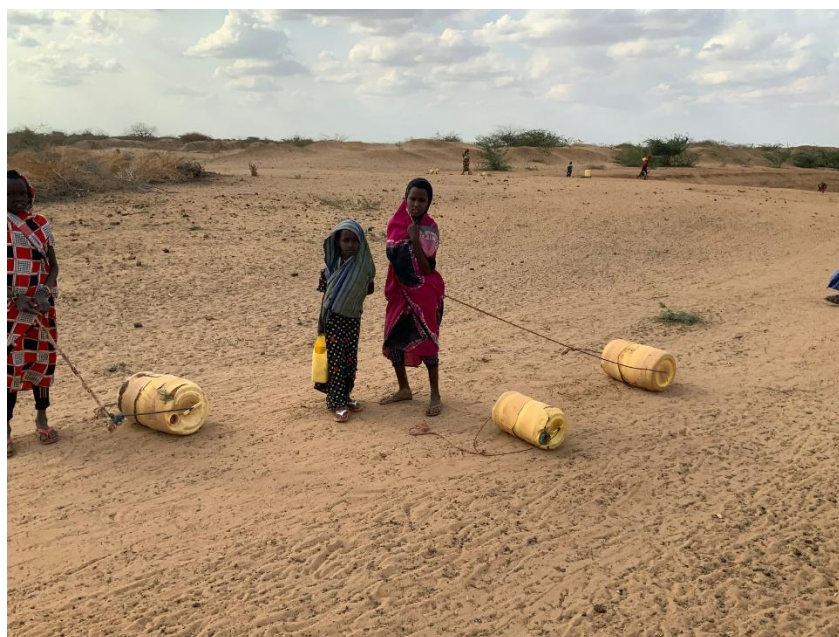
To cope with the long distances and the heavy burden of carrying water jerricans, women and children use an improvised method. A jerrican filled with water is wrapped in a broken jerrican casing, with a string tied to both ends. This setup allows the container to roll on the ground as it is pulled while maintaining quality of the water in the jerrican, reducing the strain and making water transportation easier over long distances, as shown in Figure 17 thereafter.

Figure 14: Adaptation of carrying water over long distances

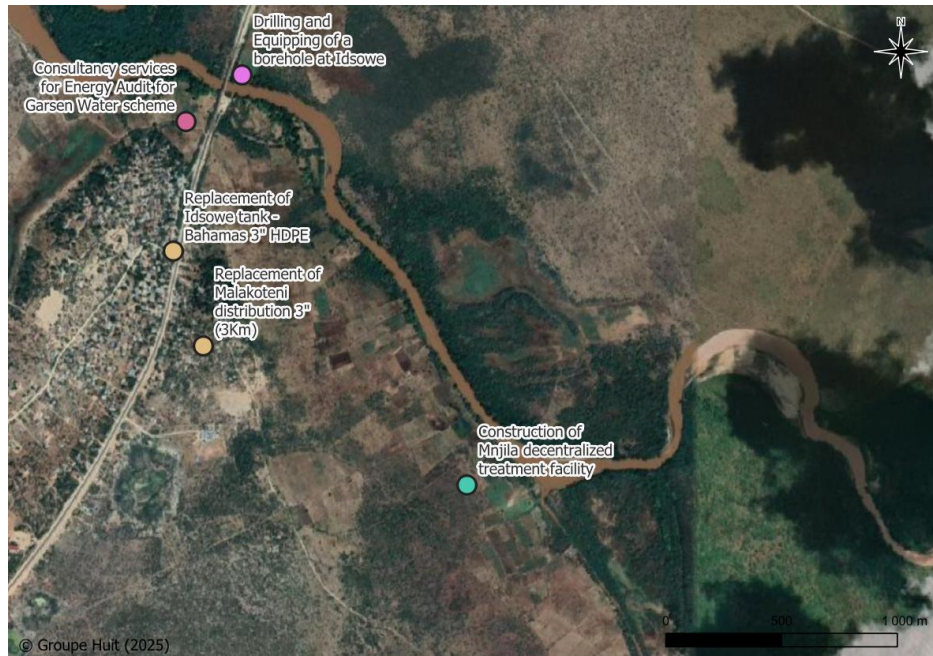
Figure 15: Proposed investment location - Construction of Minjilla desentralized treatment facility

Minjilla decentralized treatment facility with a mini grid. The construction works will involve Survey and mapping, Civil design, Process design, structural design, architectural design, electrical, construction of DTF and Construction of 100No. safisan Households toilets in Minjilla Town.

Coordinates : -2,30399 ; 40,13608

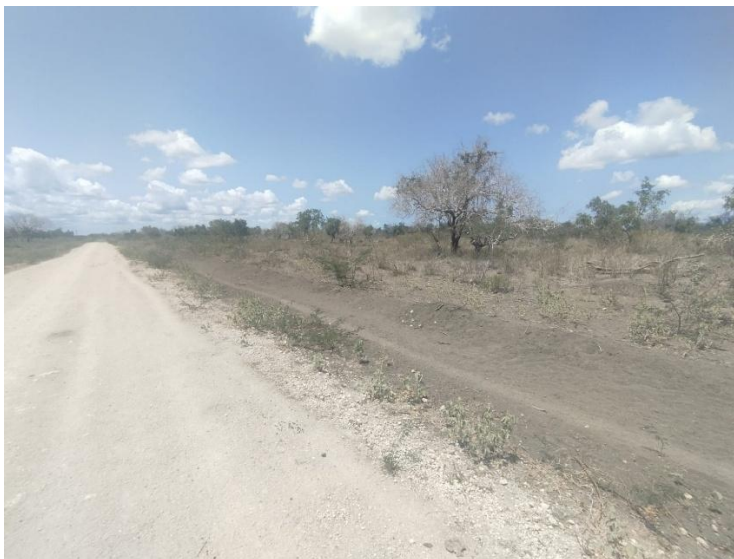
The site is presently dominated by bushland vegetation, mainly *Acacia* species, *Prosopis juliflora*, and other shrubs. It is accessible through a wide murrum road and is underlain by black cotton soils, as illustrated in Image 12 below.

Figure 16: Proposed Minjilla Decentralised Treatment Facility Project Site

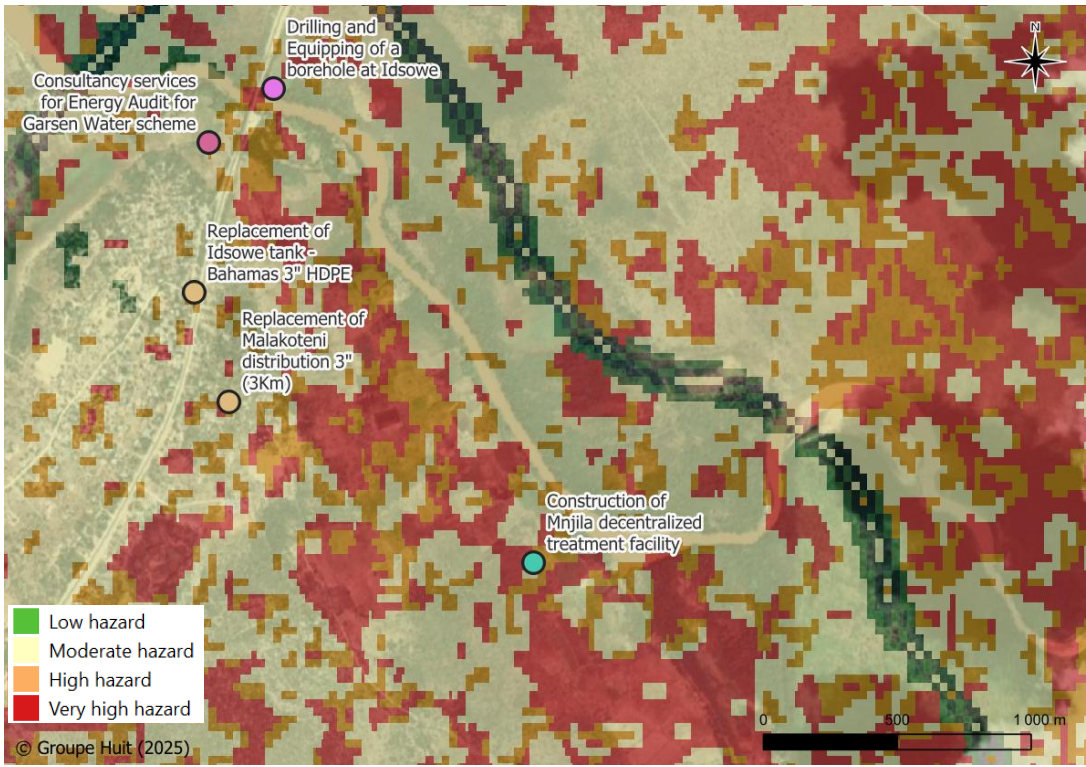
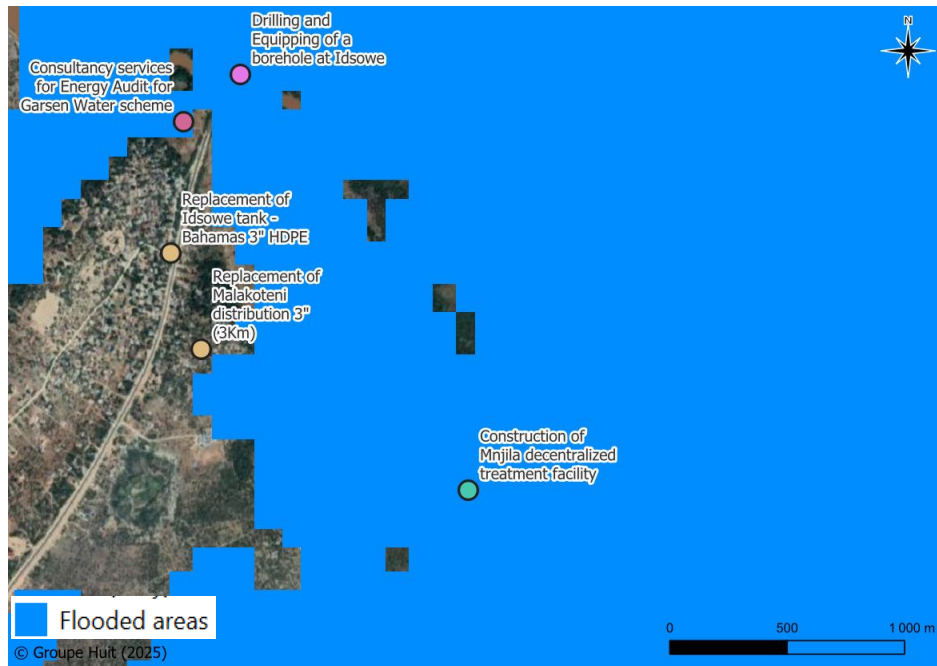
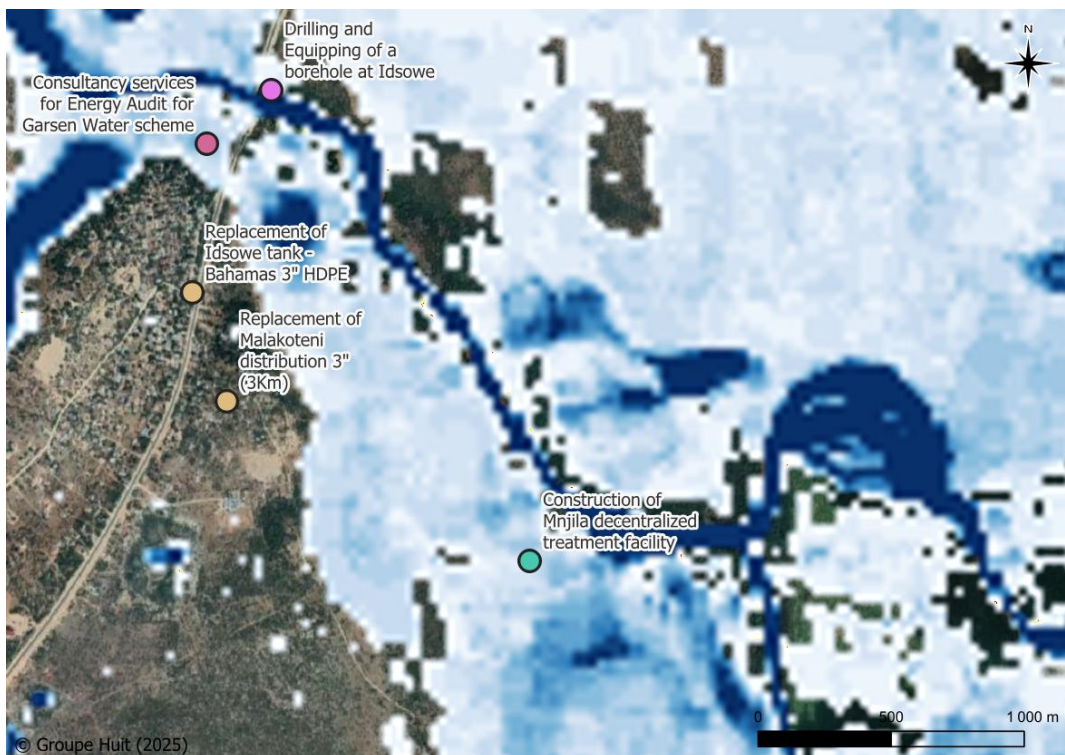
According to GIS analysis of hazards datasets this proposed investment is **very exposed to climate hazards**, especially flooding with **very high exposure to all kinds of flooding** (pluvial, river, rising water tables). Salinity does not appear to be the main concern as exposure is considered low to moderate. Finally, Tana River CRA had shown that the area is **highly exposed to heat stress and droughts**, and these hazards should therefore be considered as well.

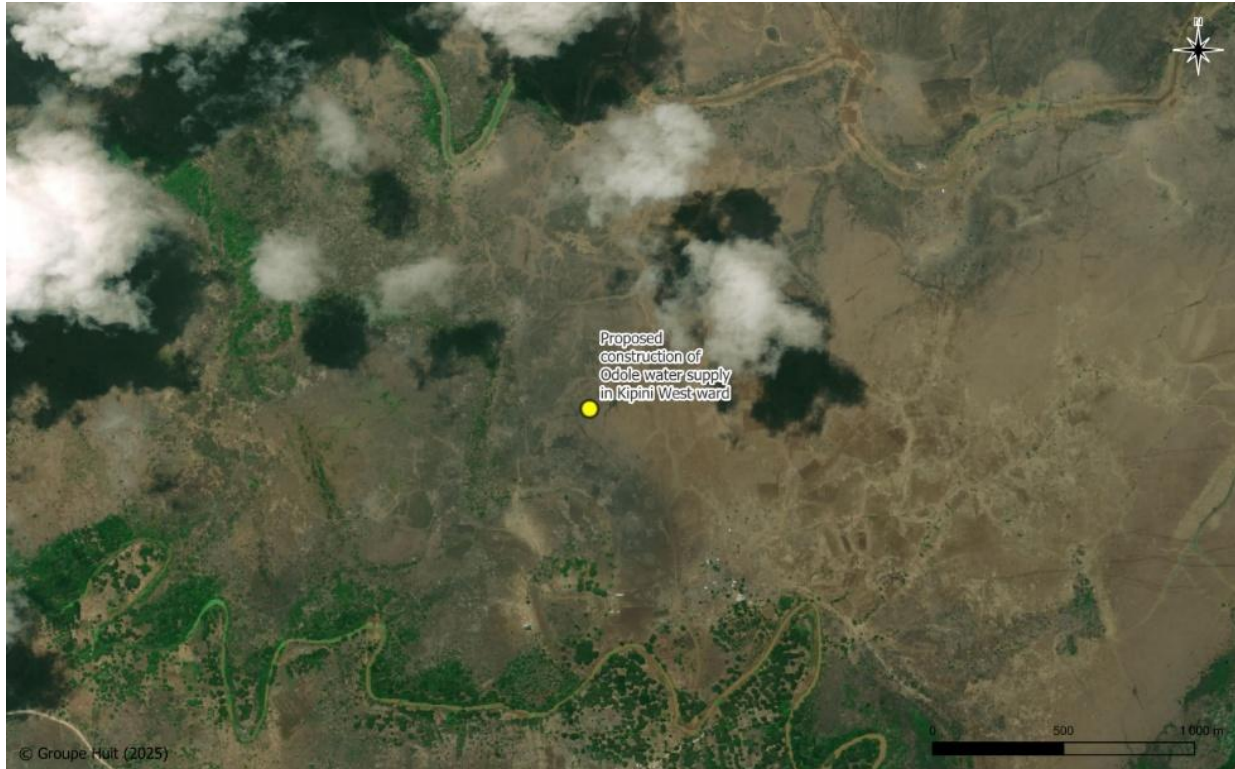
Figure 17: Proposed investment location – Construction of

Odole water supply in Kipini West Ward. The construction works will include the drilling and equipping of a borehole, solarized, 1No. Water kiosk, inline chlorine dosage, fencing and an elevated water tank.

Coordinates : -2,50709 ; 40,32281

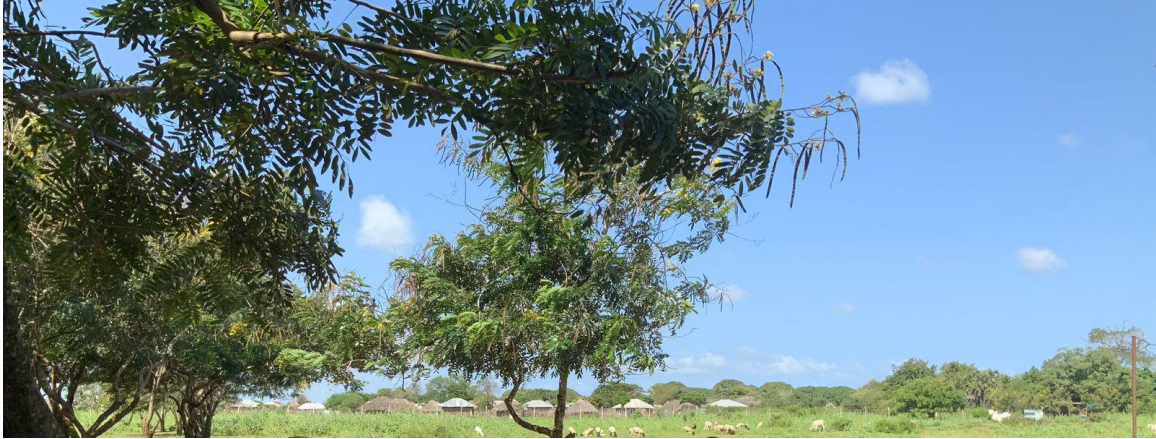
Settlements are clustered with 400 households and a population of 2400, consisting of a mix of iron-sheet and grass-thatched houses, many of which are built on raised foundations to reduce the risk of floodwater entering the homes. The 400 household units depend only on 3 toilets flush toilets with a septic tank.

Figure 18: Odole Village Settlement Cluster

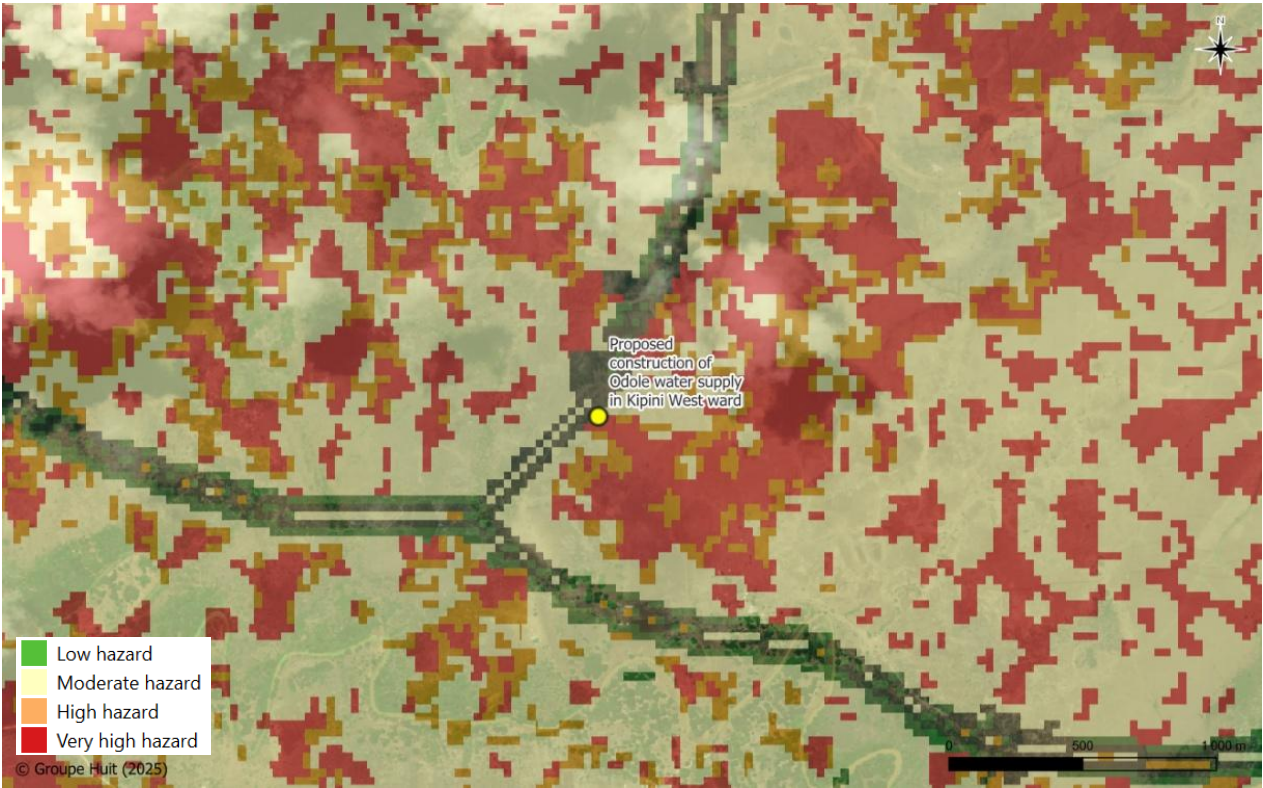
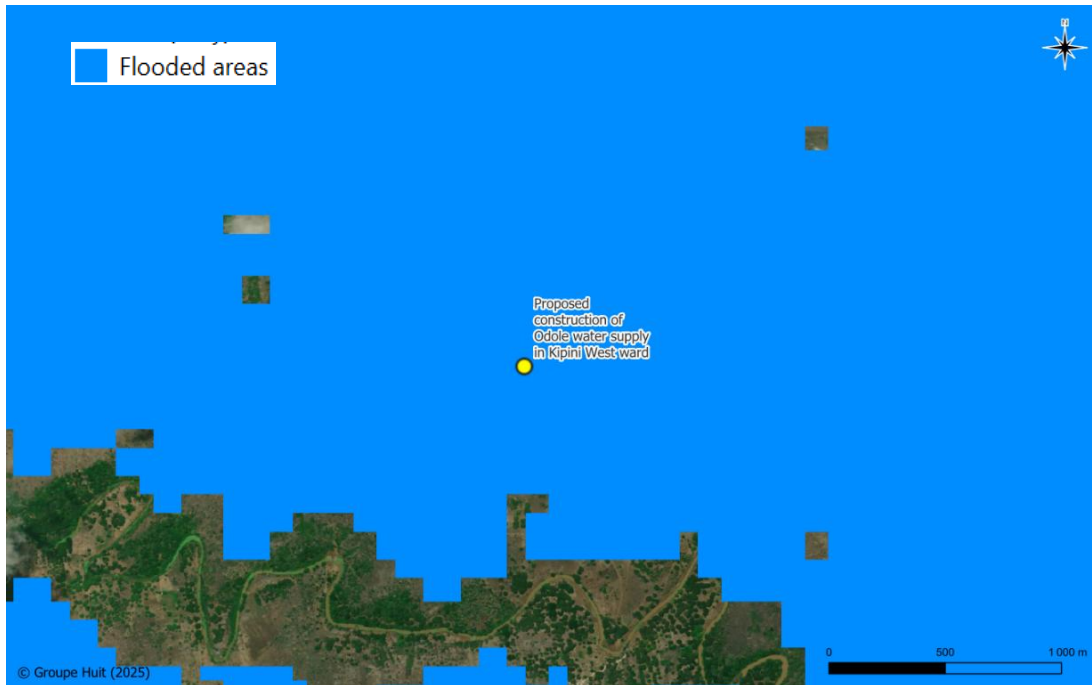
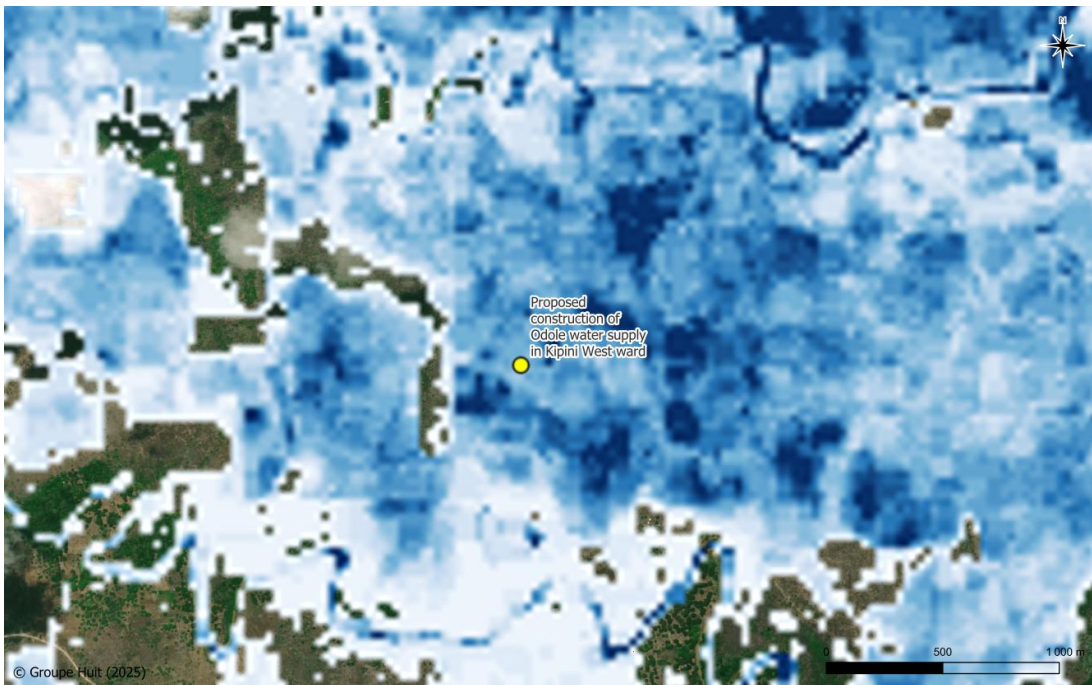
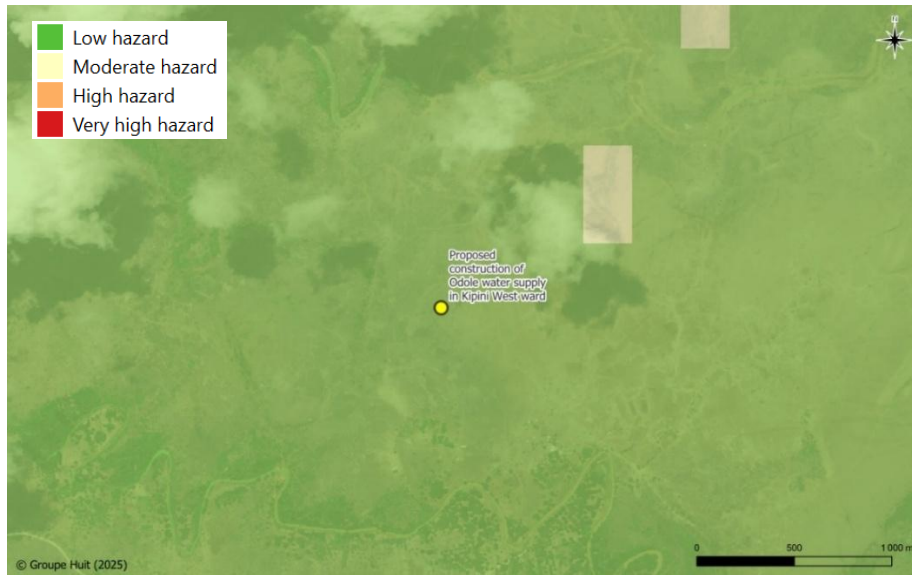
According to GIS analysis of hazards datasets this proposed investment is **very exposed to climate hazards**, especially flooding **with very high exposure to all kinds of flooding** (pluvial, river, rising water tables). Salinity does not appear to be the main concern as exposure is considered low. Finally, Tana River CRA had shown that the area is **highly exposed to heat stress and droughts**, and these hazards should therefore be considered as well.

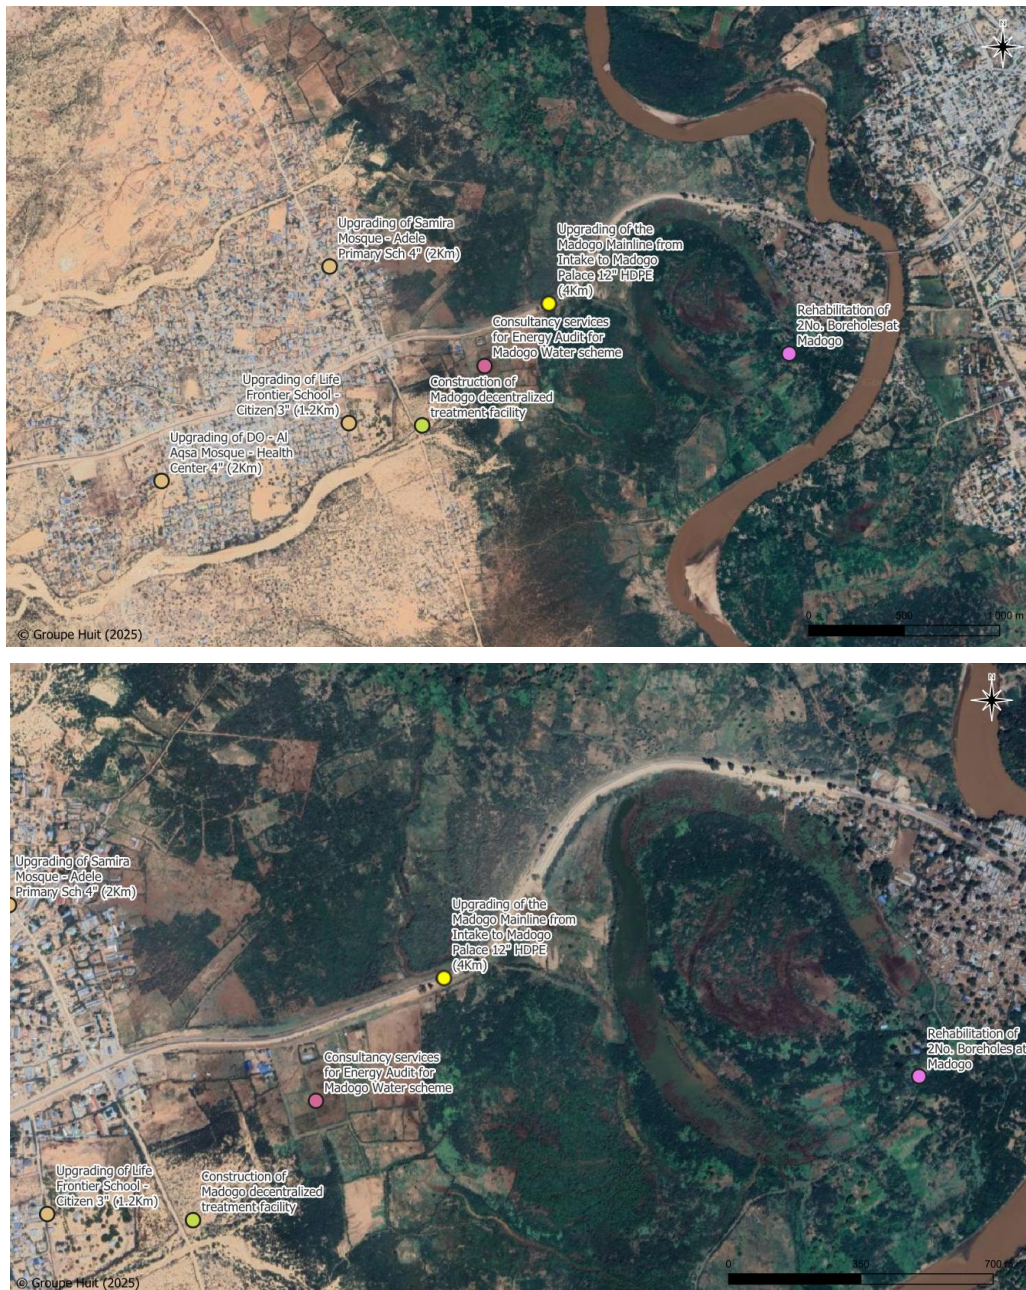
Figure 19: Proposed investment location – Upgrading of the Madogo Mainline from intake to Madogo Palace

Upgrading of the Madogo Mainline from intake to Madogo palace 12" HDPE (Distribution pipeline replacement). The works involved upgrading the existing UPVC 8" line and replace a 12" HDPE PN12.5 pipeline from the intake to Madogo Palace (4 Km).

Coordinates: -0,469194 ; 39,617181

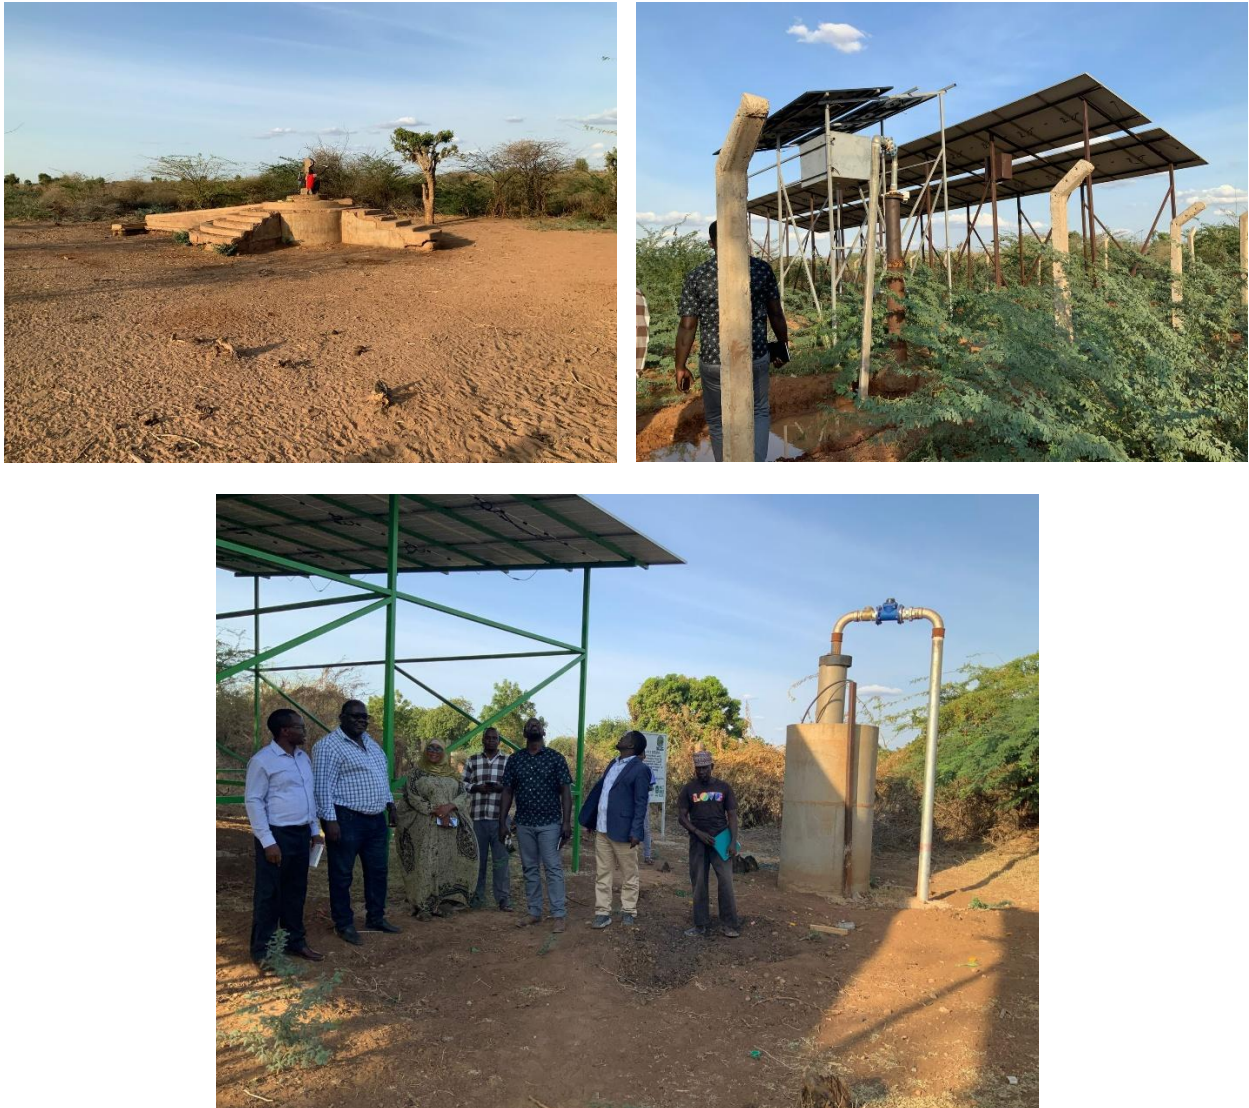
This project has been completed and is awaiting commissioning. Solar-powered borehole pumps have been installed at the Maroro Well Field and the Bulla Riama Borehole intake, as illustrated in the images below. The borehole platforms have been elevated up to 2 meters above ground level to safeguard against flooding, thereby preventing submersion of the borehole heads and contamination of the water source.

Figure 20: Operational, Solarized and Elevated borehole platforms in Madogo.

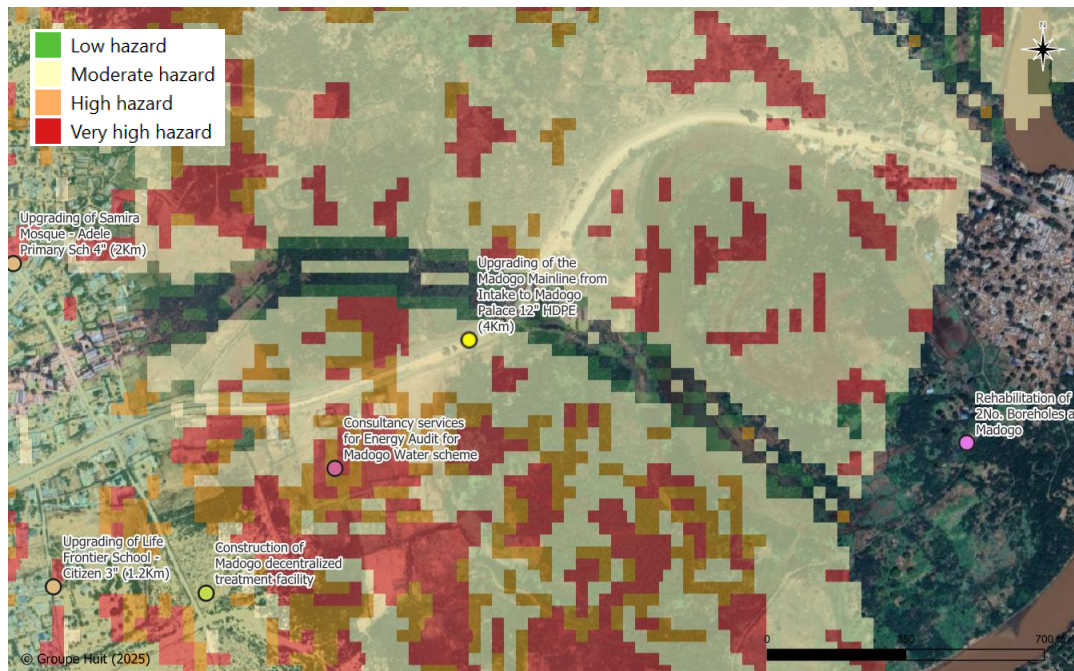
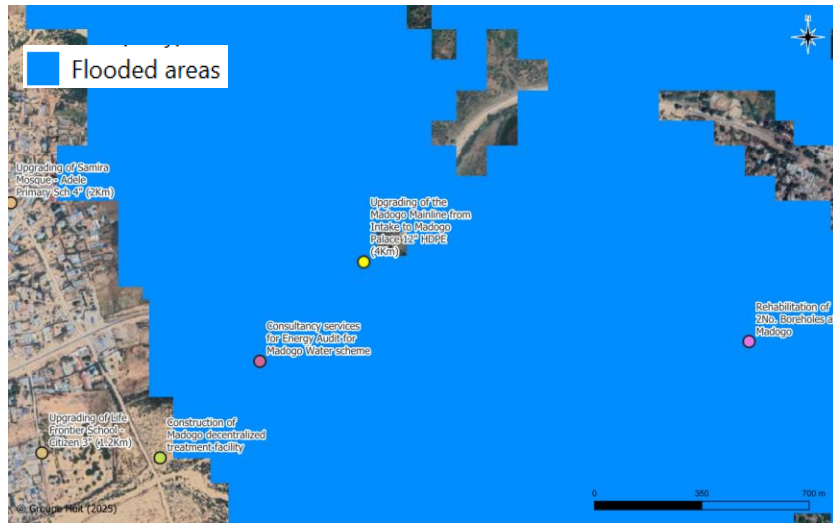
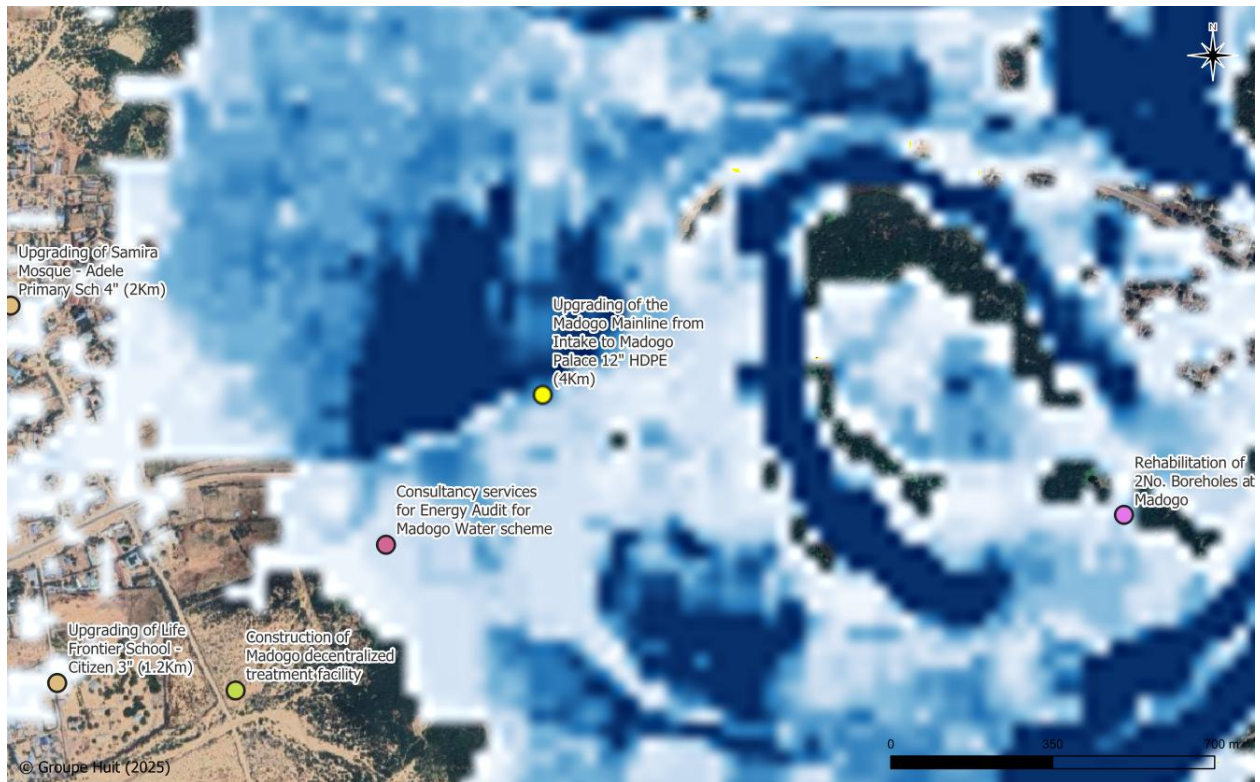
According to GIS analysis of hazards datasets this proposed investment is **very exposed to climate hazards**, especially flooding with high exposure to both river and rising watertable flooding but also moderate

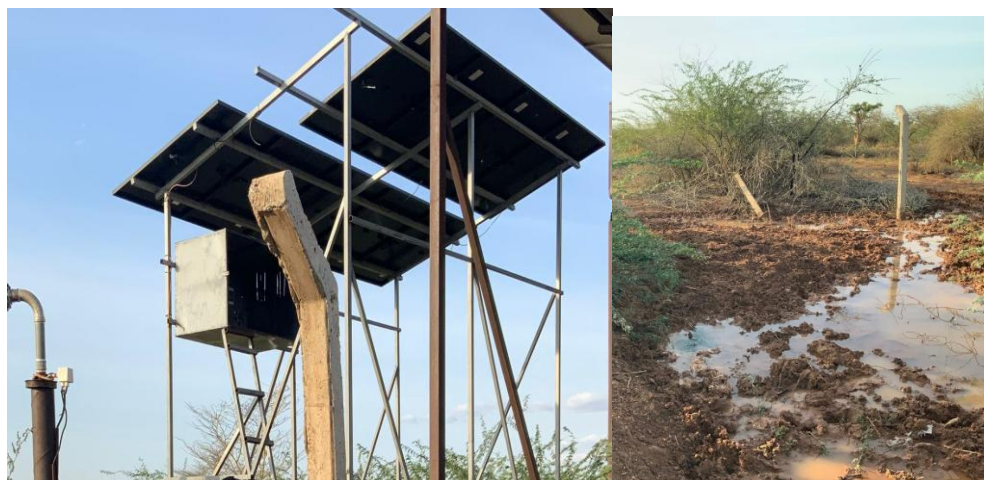
The major challenge Madogo faces is high levels of vandalism and theft of water infrastructure. Even the newly installed systems have already experienced the loss of a solar panel and a broken pipe caused by herders watering their livestock, despite the design including a cattle-watering trough at the borehole platform. Fences have also been vandalized and stolen, disrupting the steady supply of water and contributing to shortages in the town.

Figure 21: Stolen Solar Panel and Broken Water Pipe in Madogo.
